INGRID ADENSTEDT

RECONSTRUCTING PHARAONIC ARCHITECTURE IN NUBIA:
THE CASE STUDY OF SAVI, SAI ISLAND

ÖSTERREICHISCHE AKADEMIE DER WISSENSCHAFTEN
DENKSCHRIFTEN DER GESAMTAKADEMIE, BAND 80

The Case Study of SAV1, Sai Island

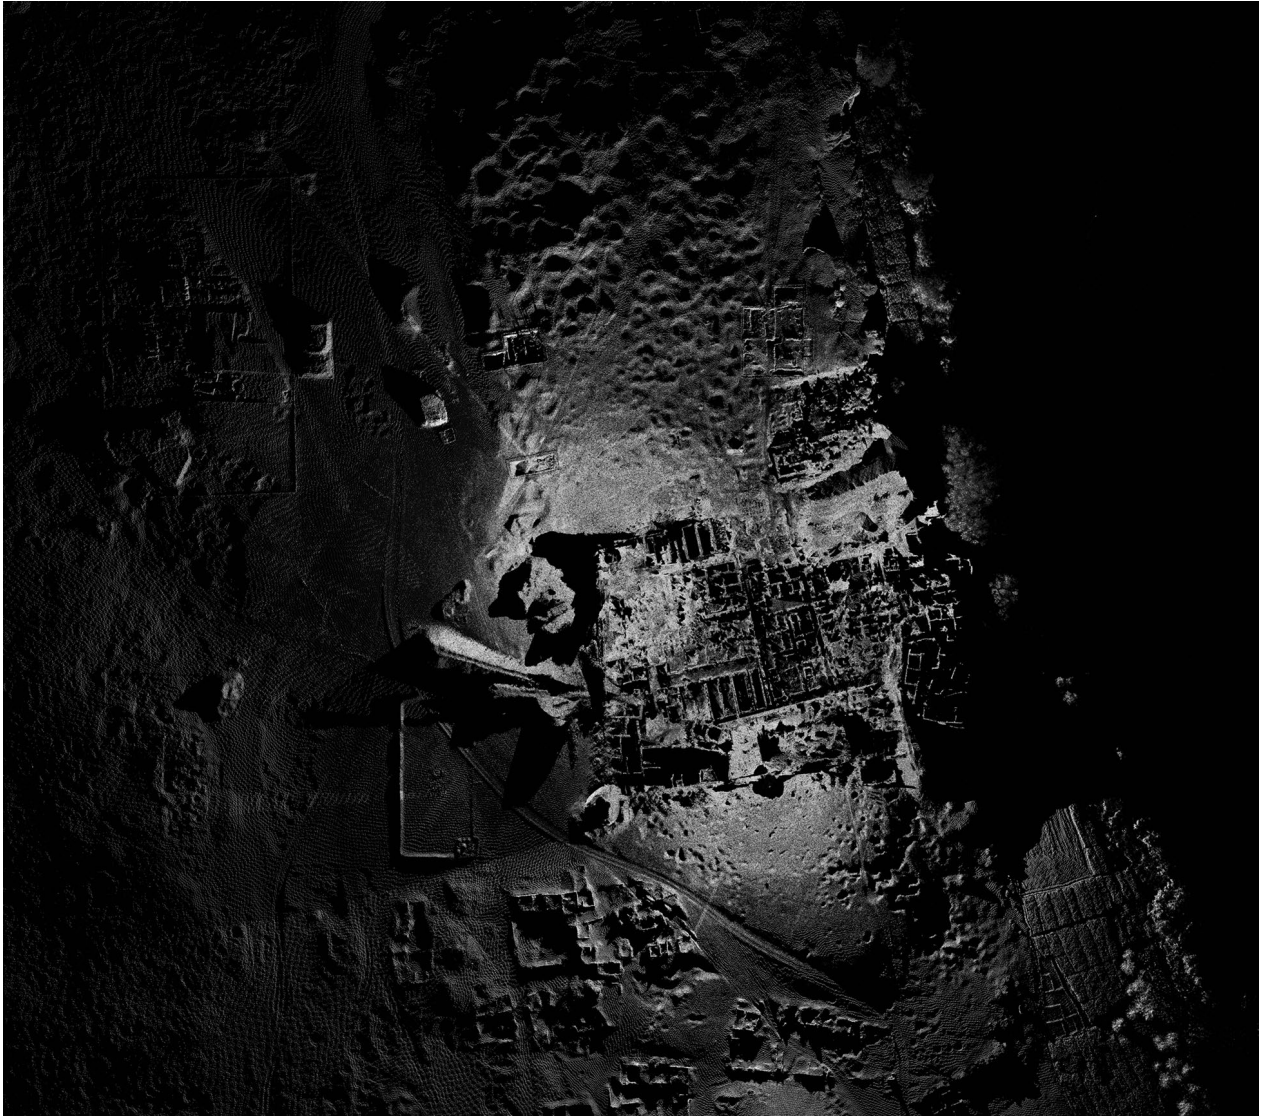
Fig. 2. Long-range 3-D laser scan plan (R. Kalasek)

ing out these steps and taking certain vital settings into consideration, such as deviation, the range and the reflectance, a smooth data transfer into a further post-processing software was possible. In our case, the software program PointCab²⁹ seemed to be the best solution for creating plans (Pls. 1–12) and sections directly from the 3-D point cloud, which can then be further worked out in AutoCad (Plans 1–4).

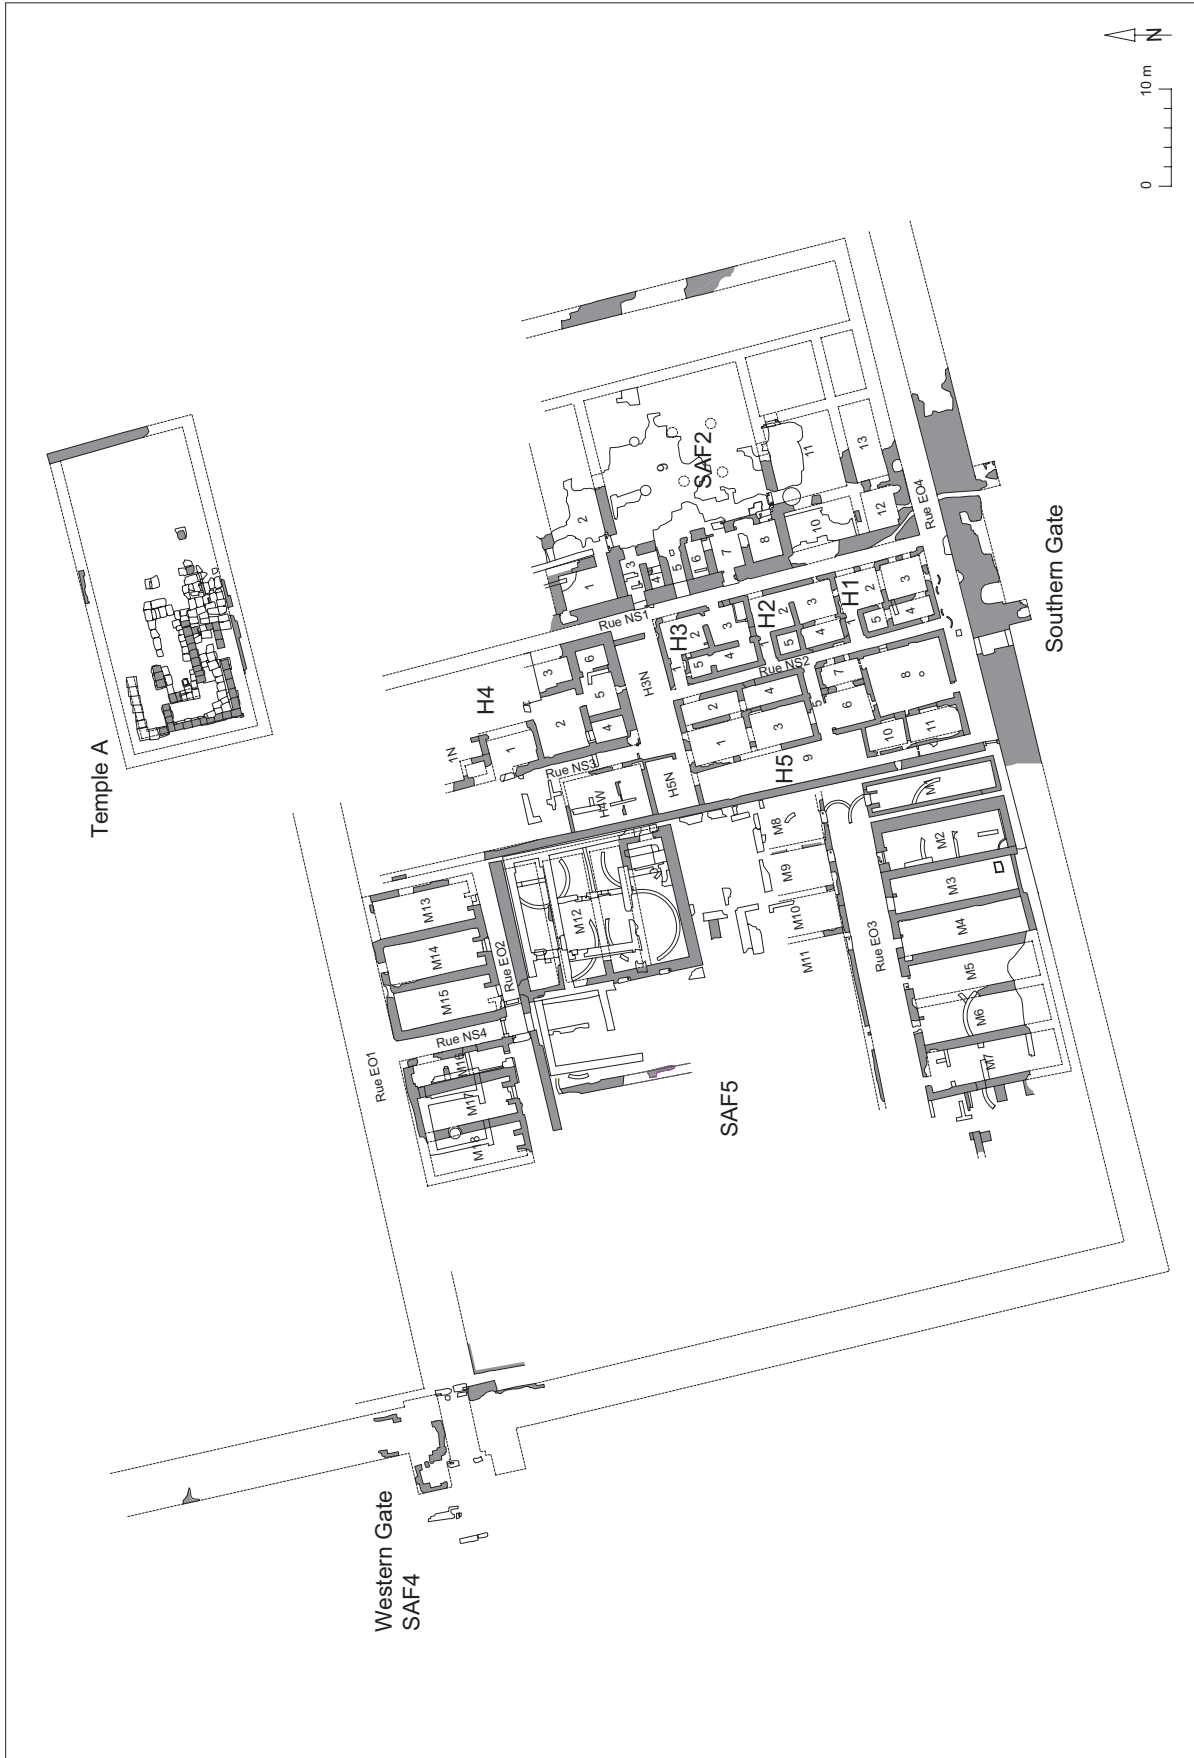
Fig. 4. Plan of the remains of SAV1 based on the 3-D laser scan

with the actual state of the ruins and one with a reconstruction of the settlement, particularly SAV1 (Figs. 4 and 5). As a further step – and from the beginning one of the goals of the project – a 3-D reconstruction of the area SAV1 was attempted (Pl. 62). Due to the state of the ruins, a lot of the reconstruction must however remain hypothetical, especially when going into the third dimension, determining building elevations and adding possible upper stories. For the most part, the consid-

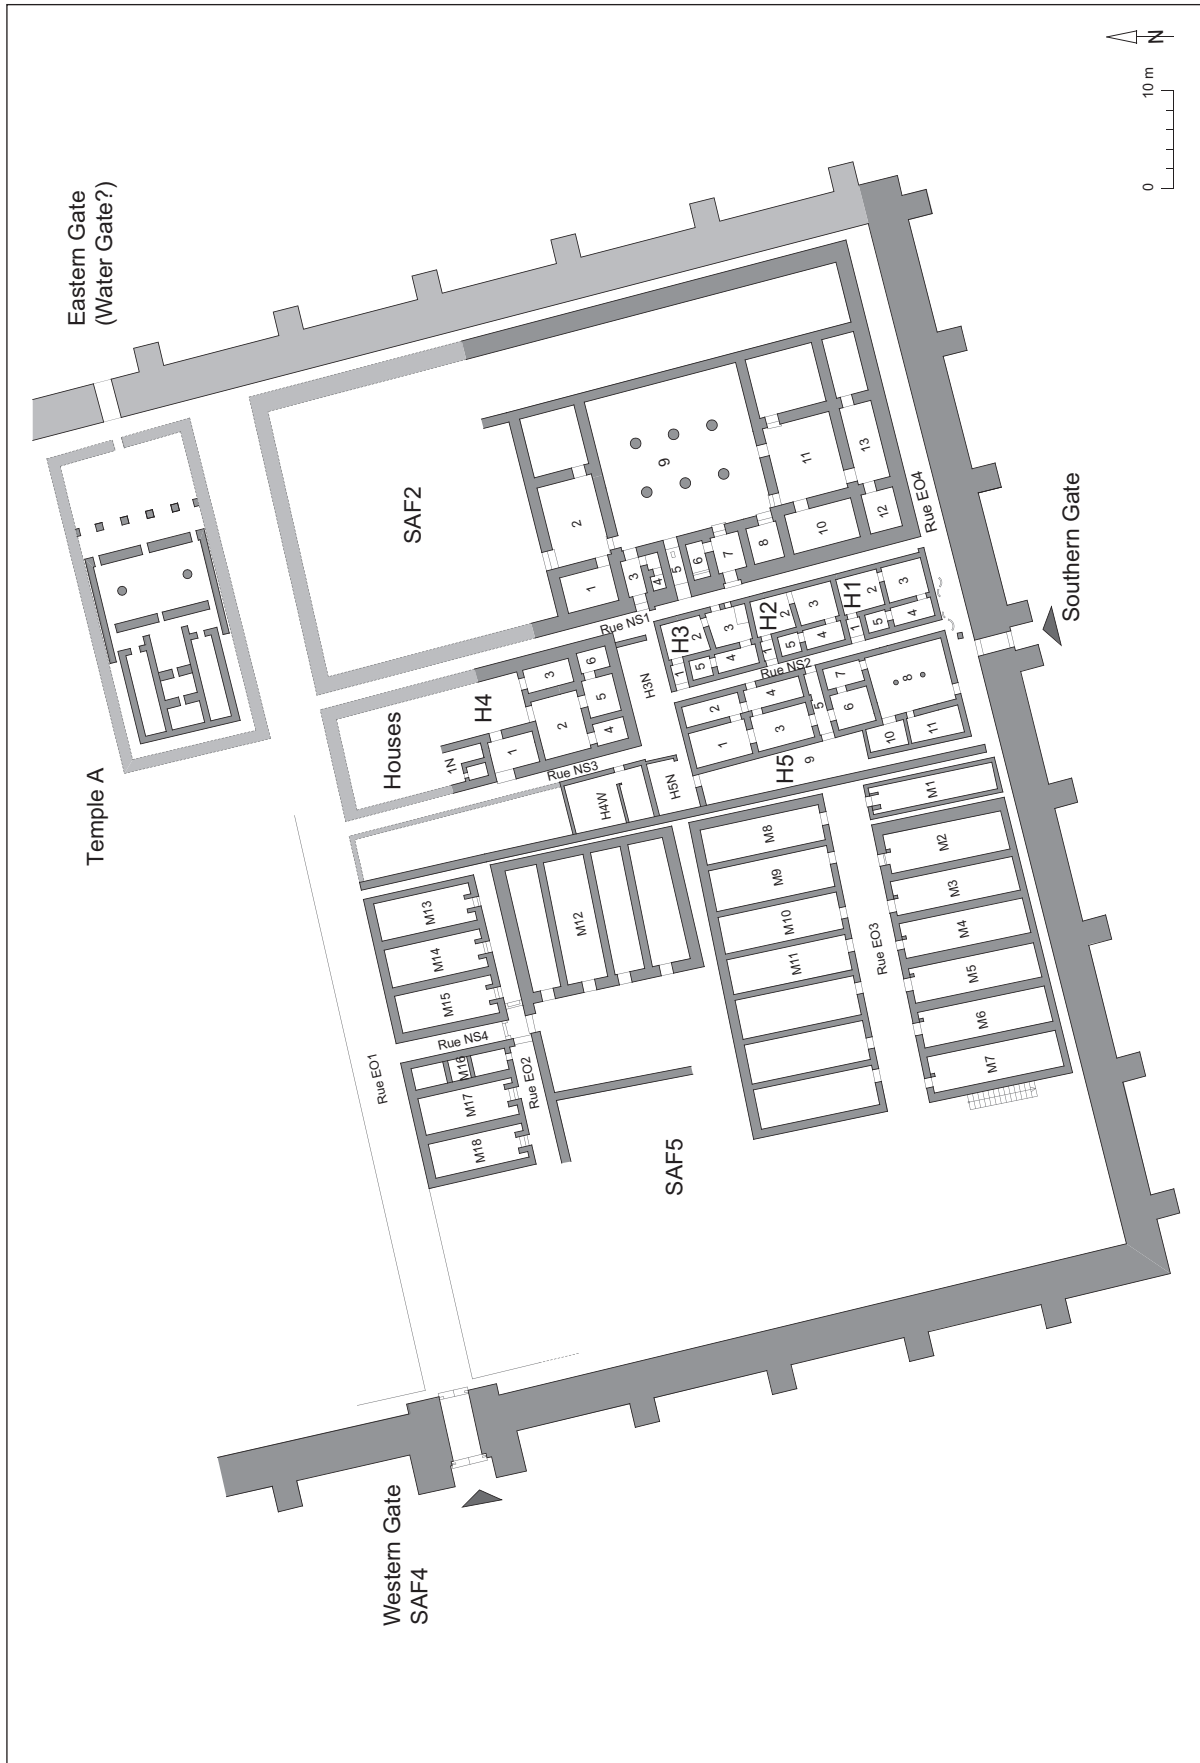
Fig. 5. Reconstruction plan of SAVI

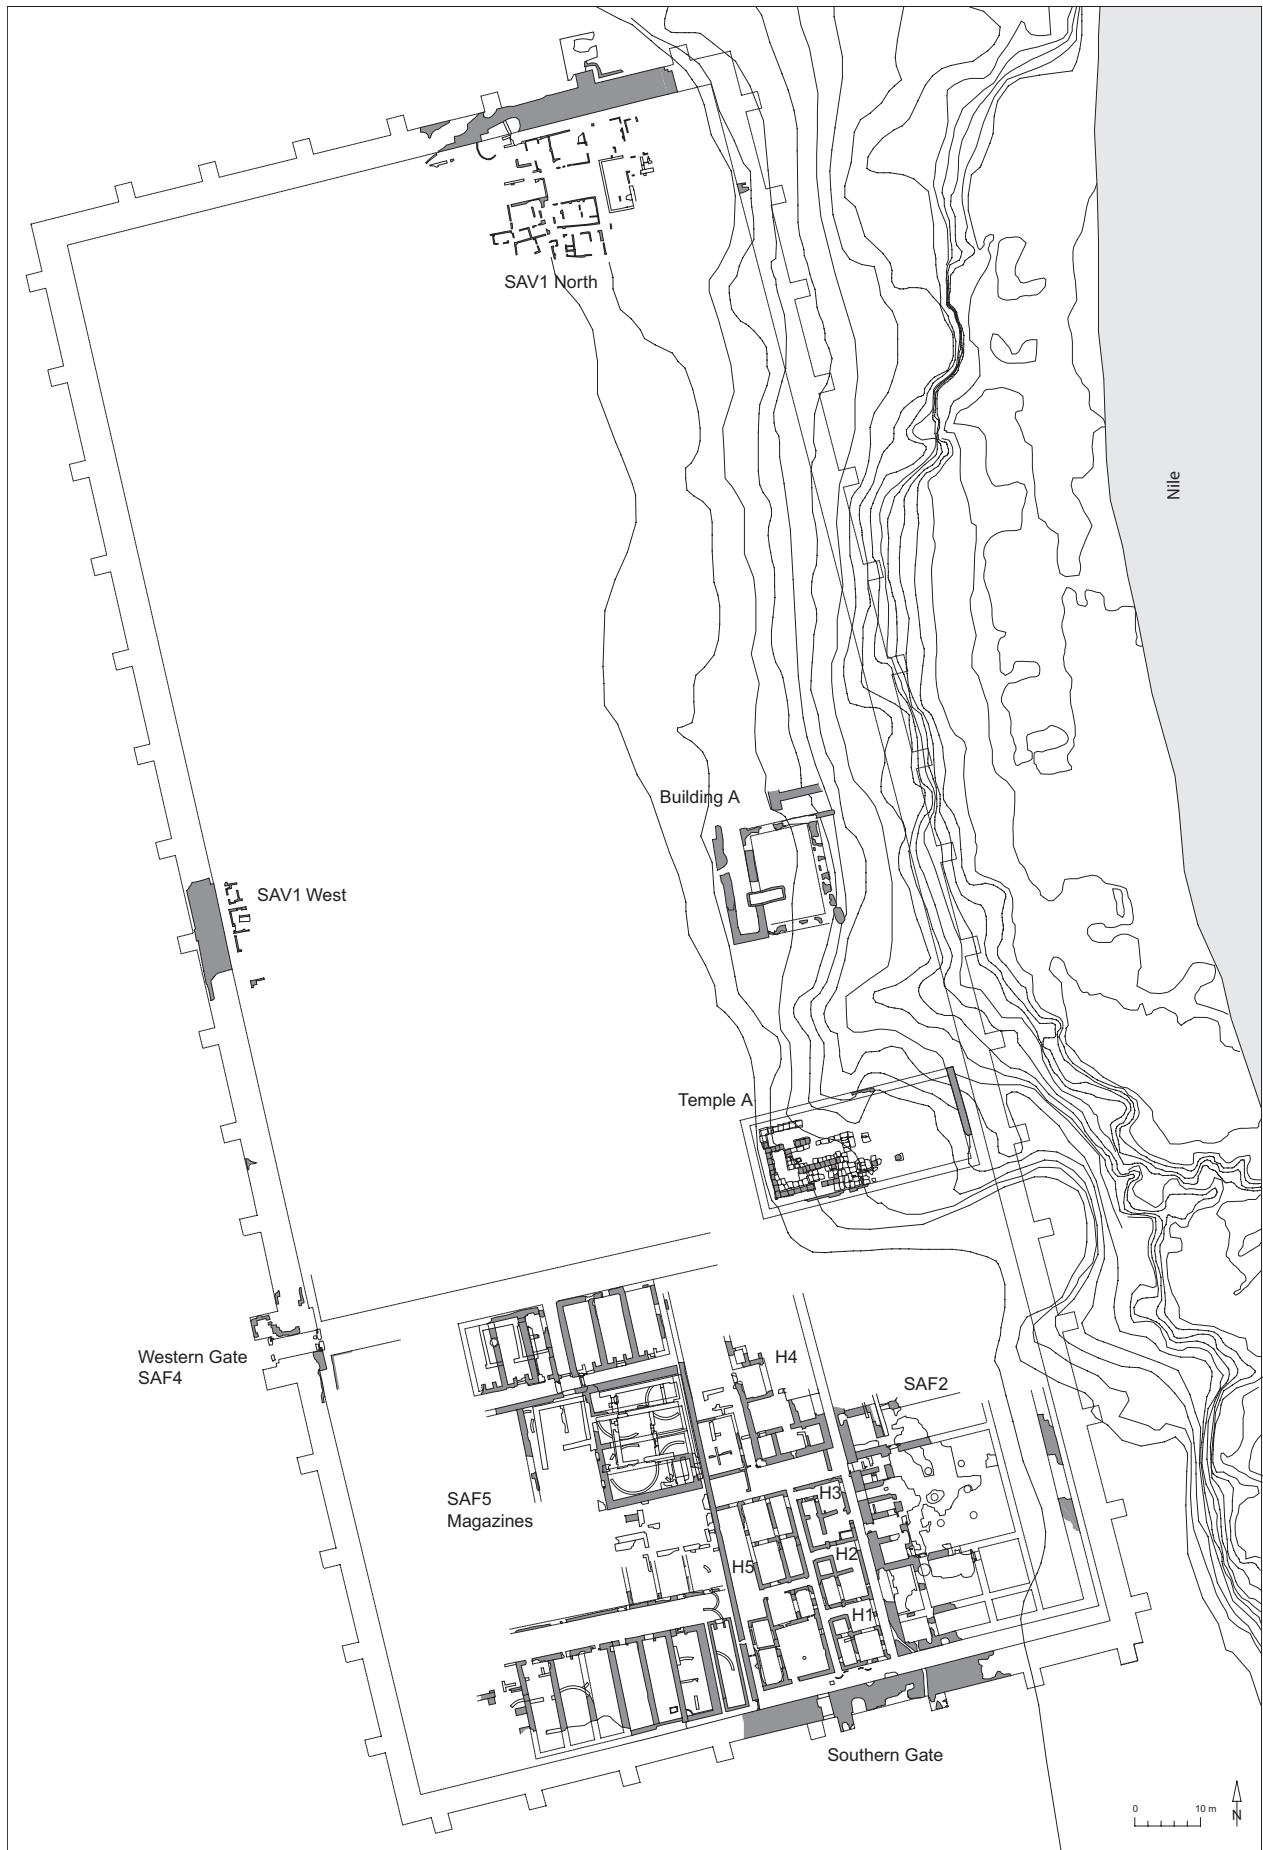
Fig. 7. Plan of the Pharaonic town of Sai in its topographical setting

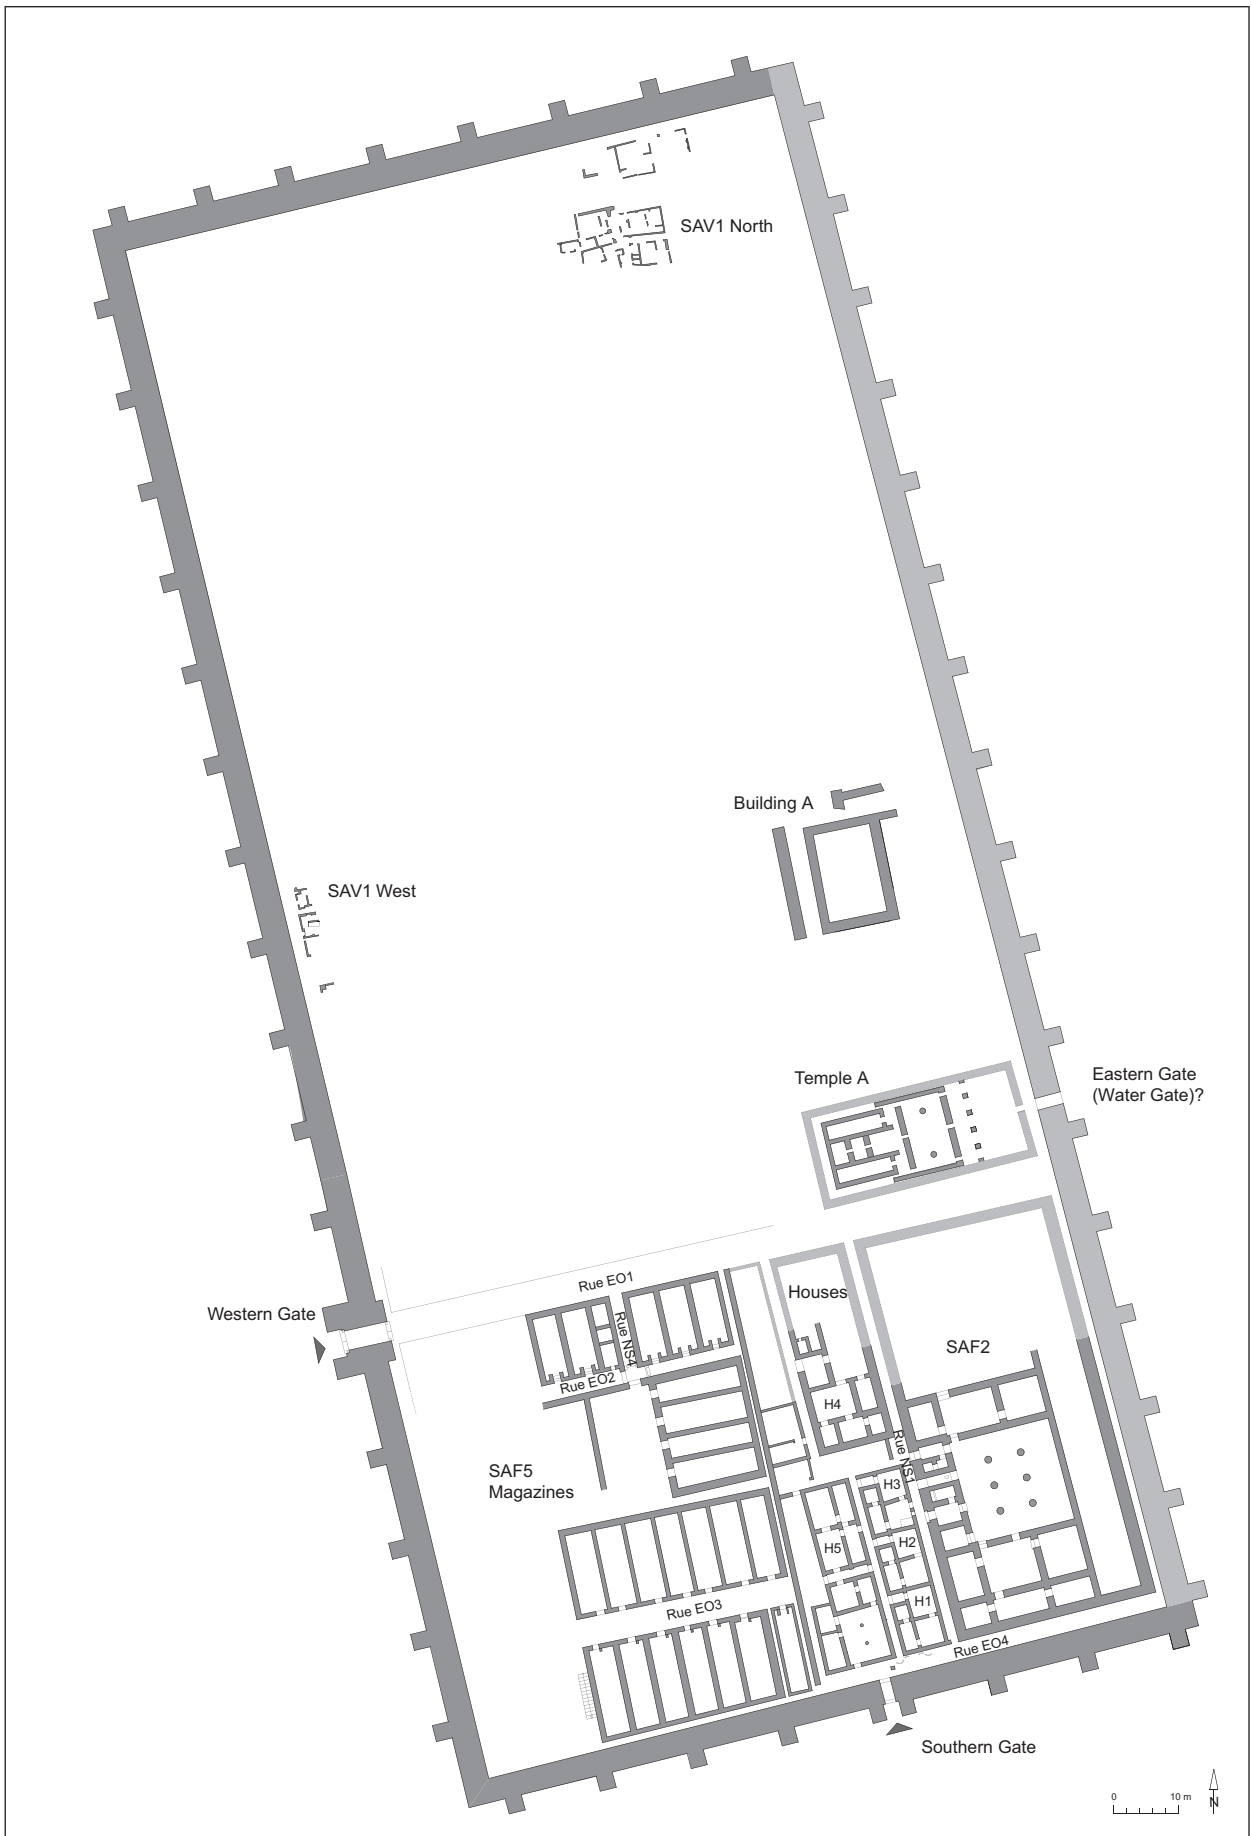
Fig. 8. Reconstruction plan of the Pharaonic town of Sai

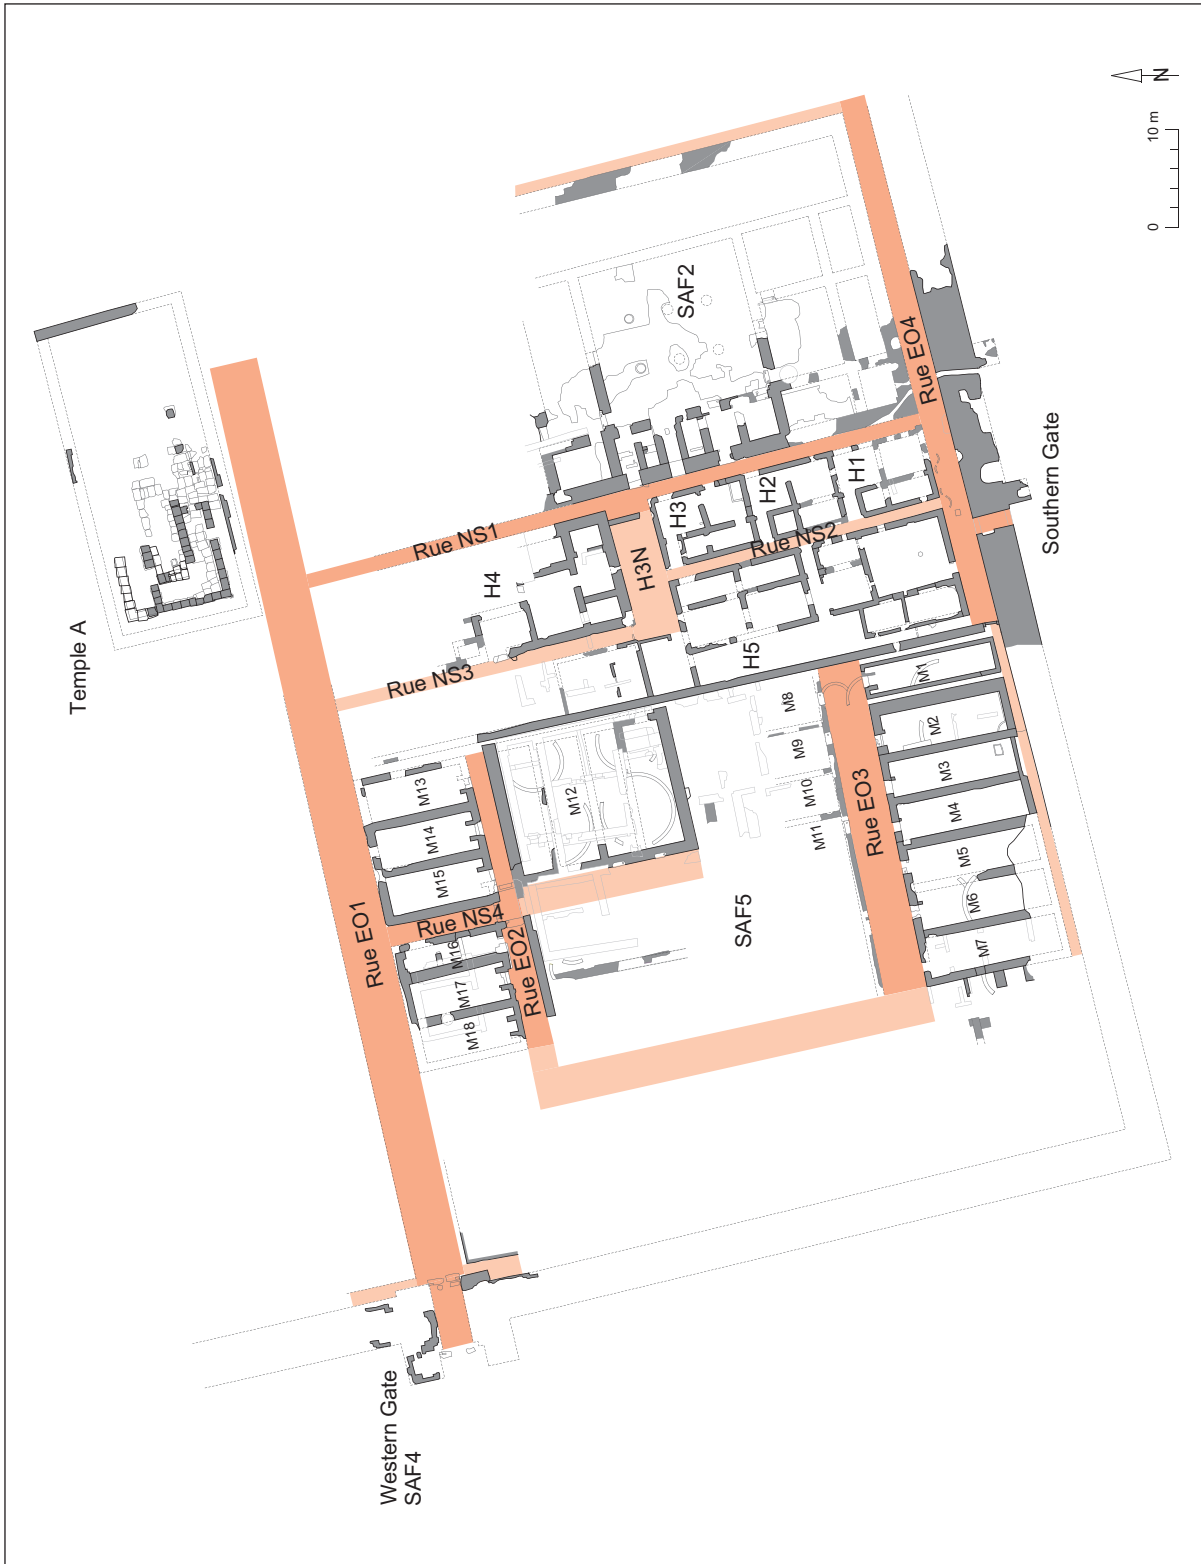
Fig. 9. The streets of SAV1

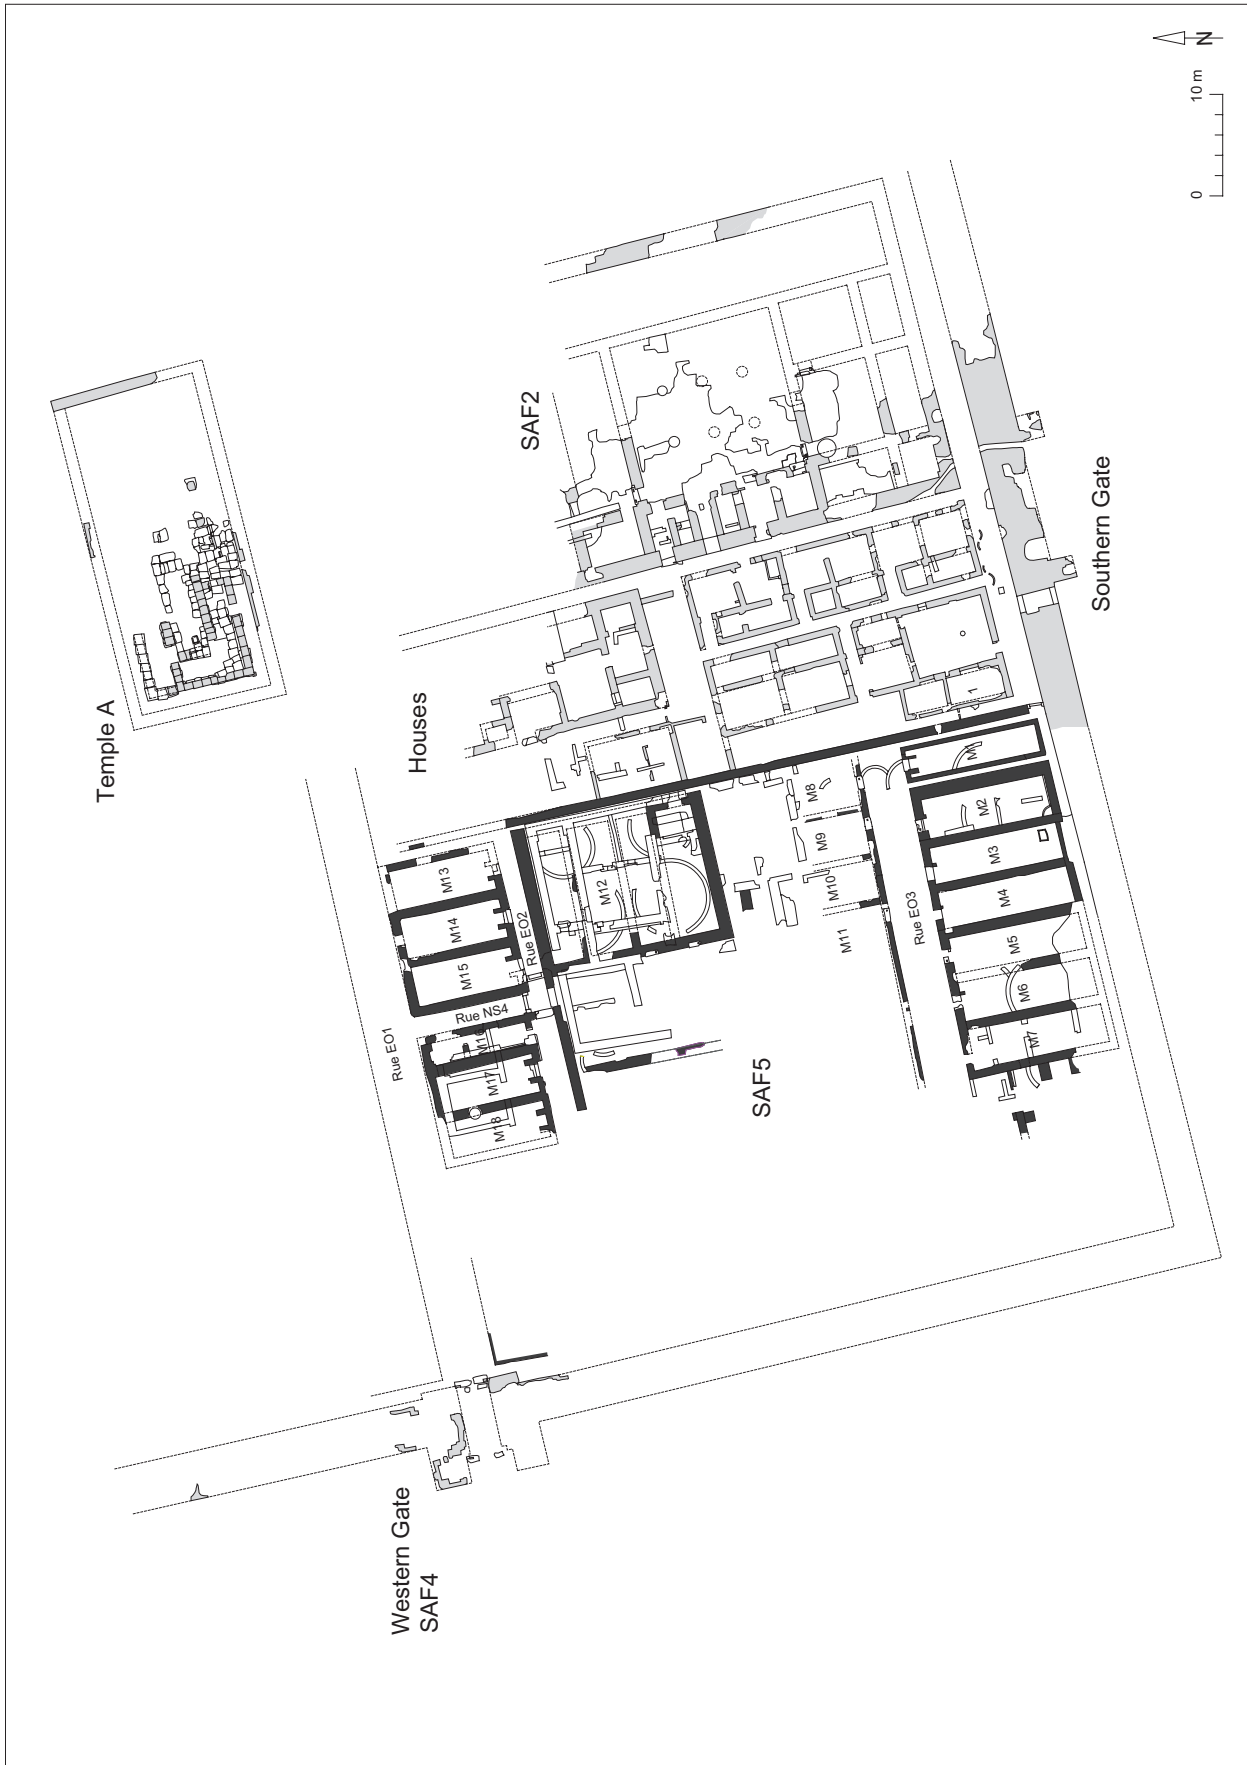
Fig. 10. Overview of SAF5

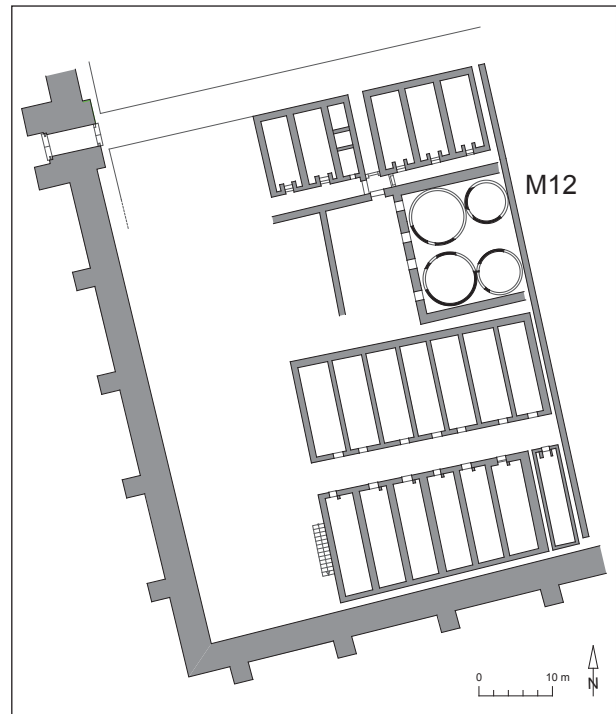
Fig. 12. Location of the phase 2 silos

Summarizing, a certain phasing can be determined:¹²⁵ in the beginning, silos for storage were erected in the area (Fig. 11). While the majority of silos could be detected on the southern side of SAF5, the remains of silos just to the south of Rue EO2 give evidence that silos could have been situated throughout the entire area of SAF5. This first phase of silos can actually be split into two sub-phases, since some of the remains overlap one another. In a second period, the rectangular storage rooms were erected. Finally, at least in the central zone (M12), these storage rooms were later replaced by four circular silos (Fig. 12), which must have occurred before Meroitic times, since they were later overbuilt by structures of this period.

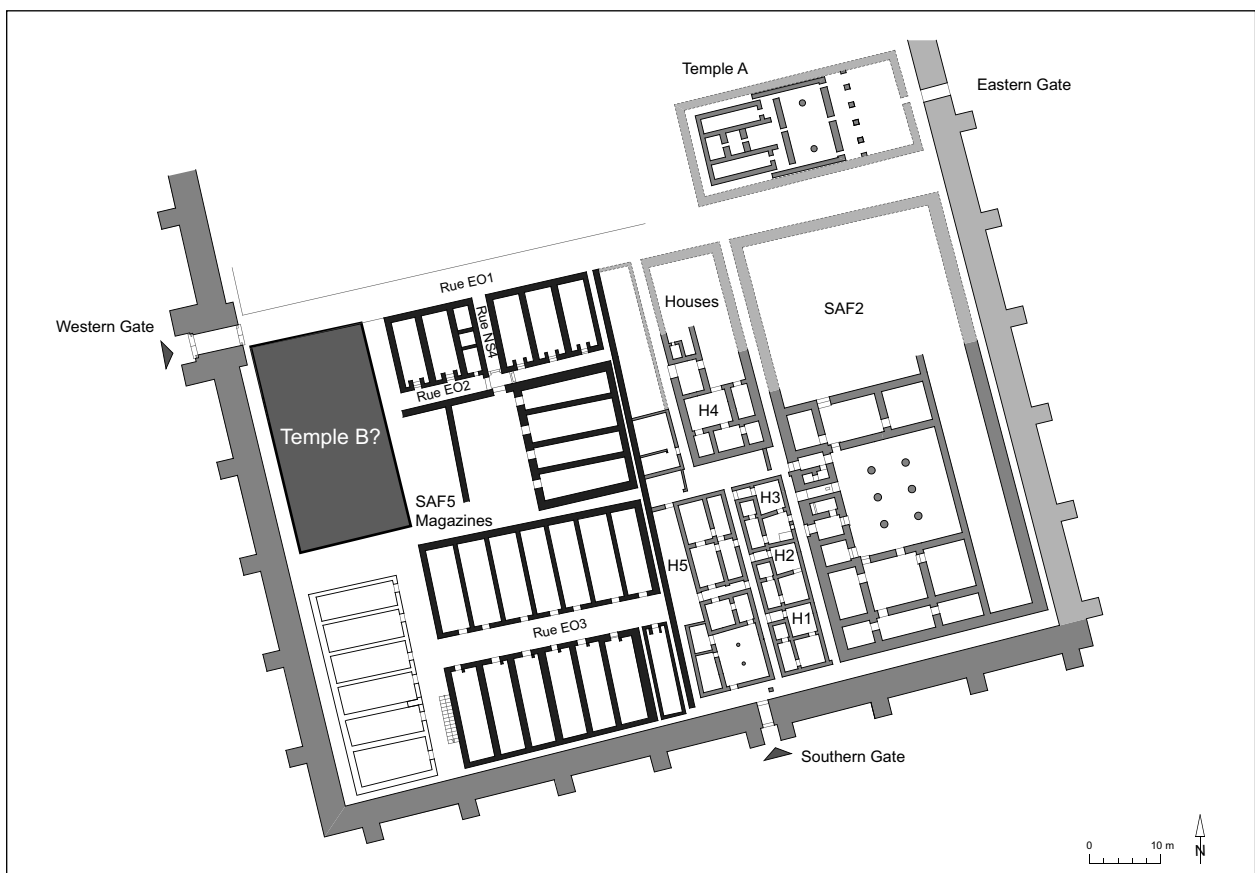
Fig. 14. Suggested reconstruction of SAF5 with a presumed second temple (Temple B)

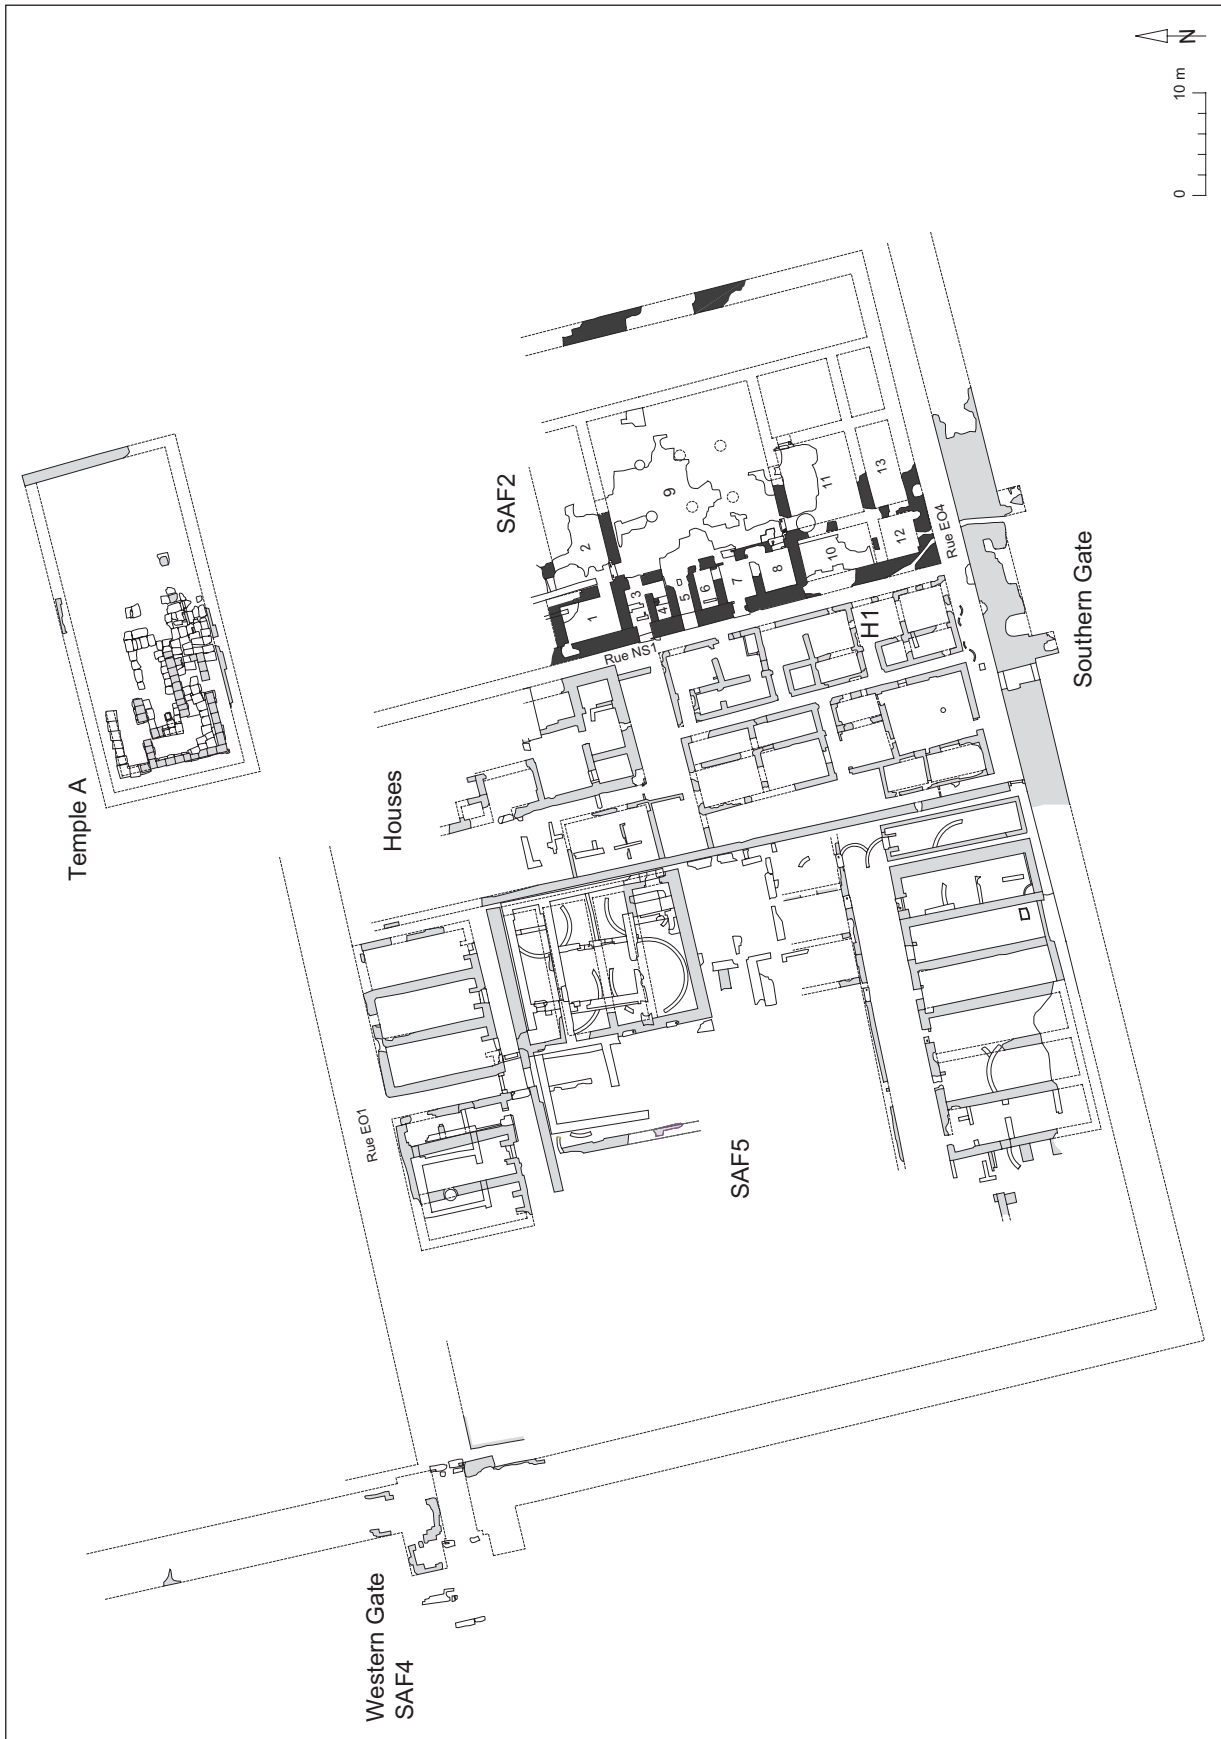
Fig. 17. Overview of SAF2

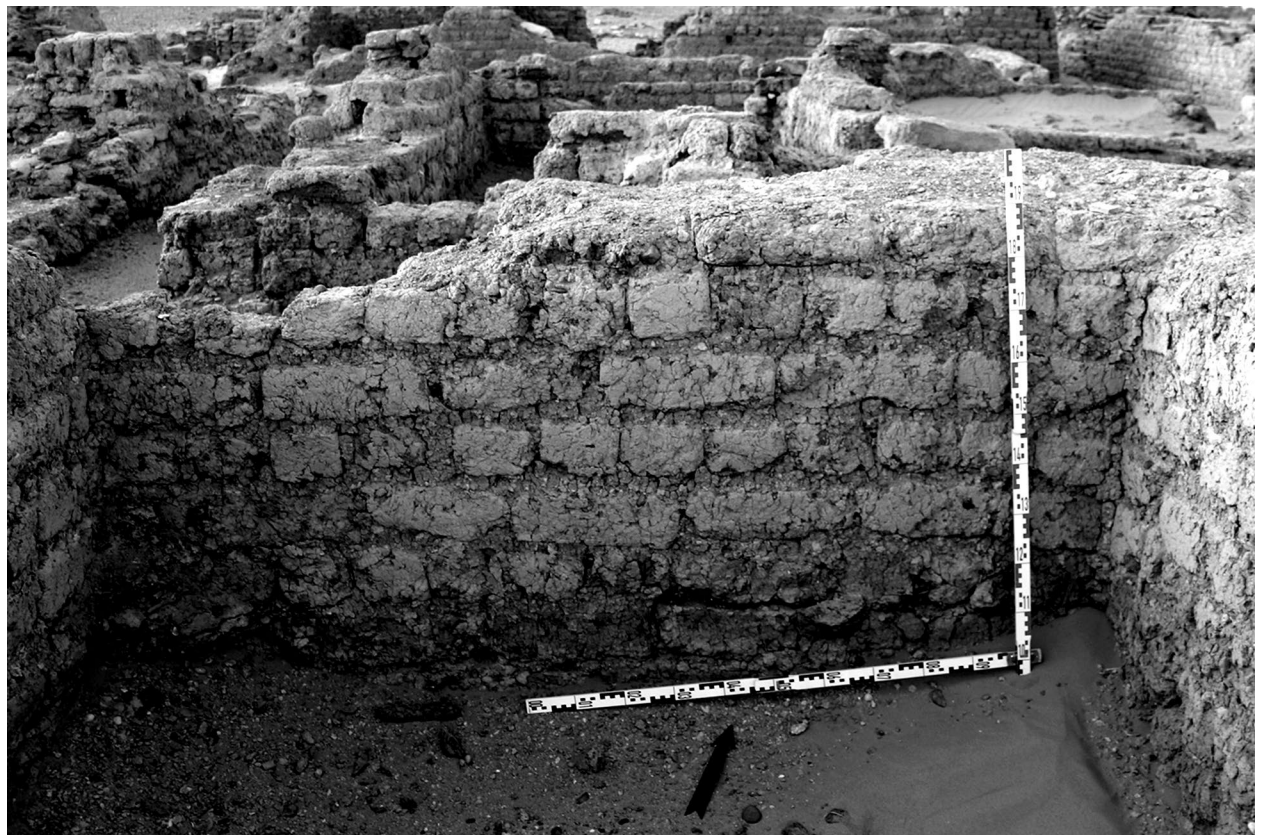
Pl. 13.3. Bricklaying technique – view of a wall in House H2

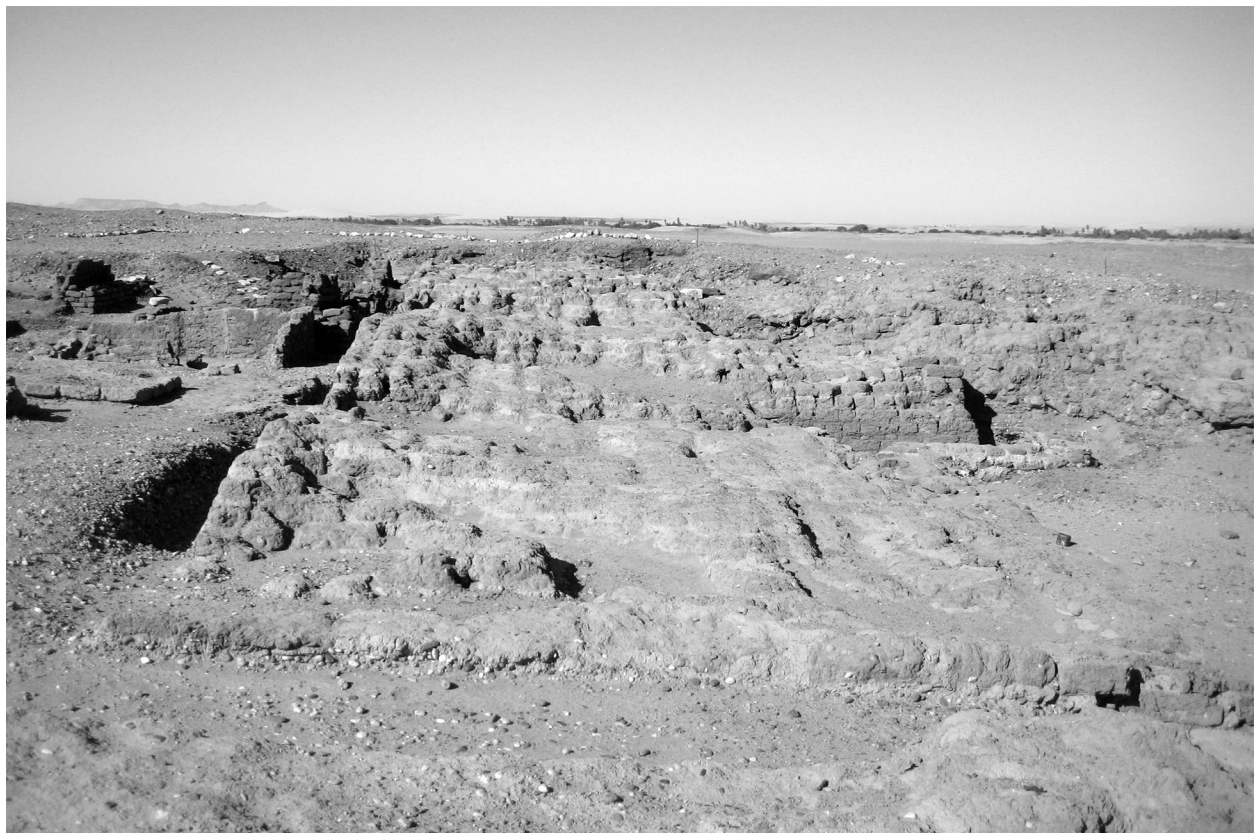
Pl. 17.3. Remains of the fortifications at SAV1 North, view from the east

On the north side of the town, remains of the enclosure wall were excavated during the campaigns in the years 2008 to 2012 (Pl. 17.3).⁷¹ They can be traced to a length of 39.32m and show similar results as in the southern part of town, with the enclosure wall being 4.26m thick, composed of ten rows of mudbrick headers alternating with layers of stretchers. Bricks laid in various positions existed as well. No gate was discovered in this part of the town wall, but a small protrusion, measuring 2.64 × 2.12m existed on the outer side, similar to the southern side of the fortification. In addition, a curtain wall surrounding the original bastions is proposed as well as an enlargement of the protrusion during Pharaonic times.⁷²

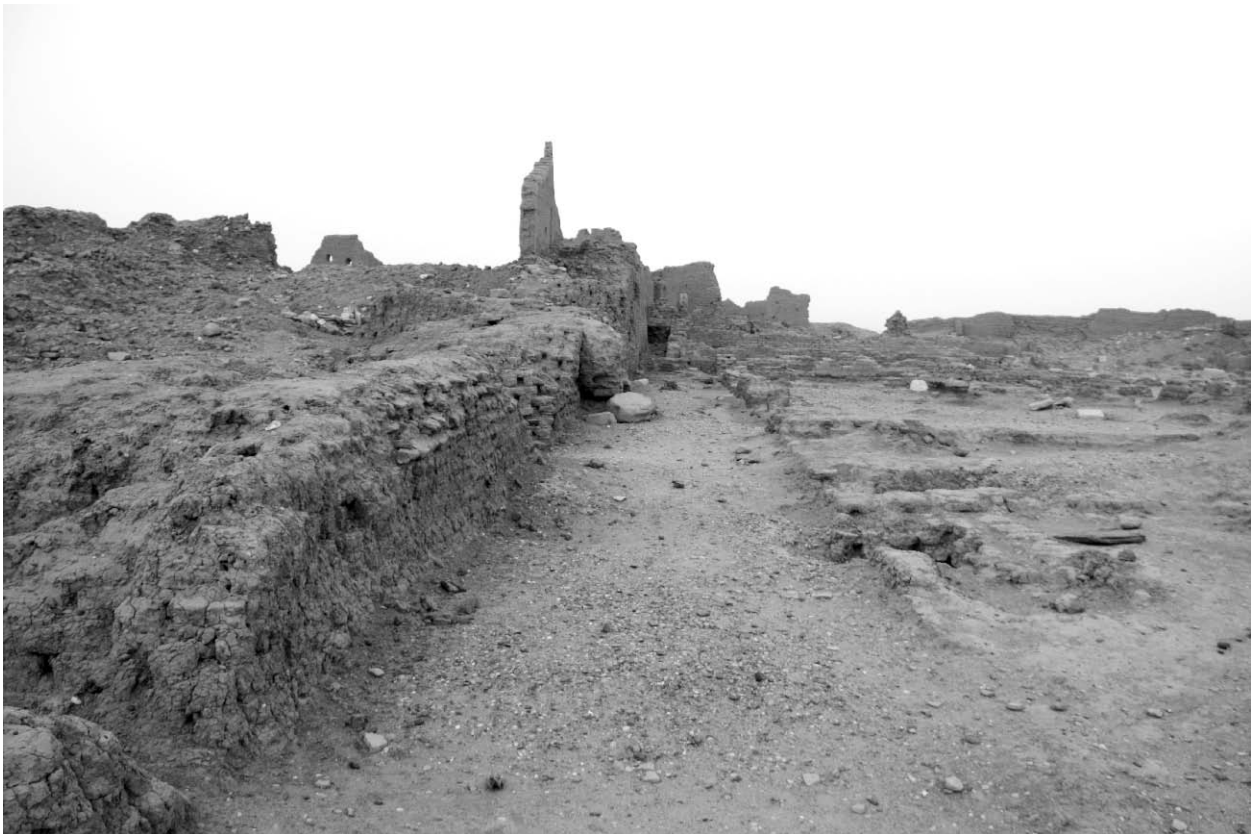
Pl. 21.2. Rue EO4, view from the east

Lastly, one further east-west oriented street is known, Rue EO4, which is situated to the south of the domestic buildings and SAF2, adjacent to the southern fortification wall (Pl. 21.2). In the west, this street ended at the partition wall to the storage area SAF5 and the eastern end is not known, since this area is either badly deteriorated or overbuilt by later structures. Rue EO4 was 2.76m wide and had crossing points with the streets Rue NS1 and Rue NS2. In the west, a further 1.12m wide north-south
