INGRID ADENSTEDT

RECONSTRUCTING PHARAONIC ARCHITECTURE IN NUBIA:
THE CASE STUDY OF SAVI, SAI ISLAND

ÖSTERREICHISCHE AKADEMIE DER WISSENSCHAFTEN
DENKSCHRIFTEN DER GESAMTAKADEMIE, BAND 80

The Case Study of SAV1, Sai Island

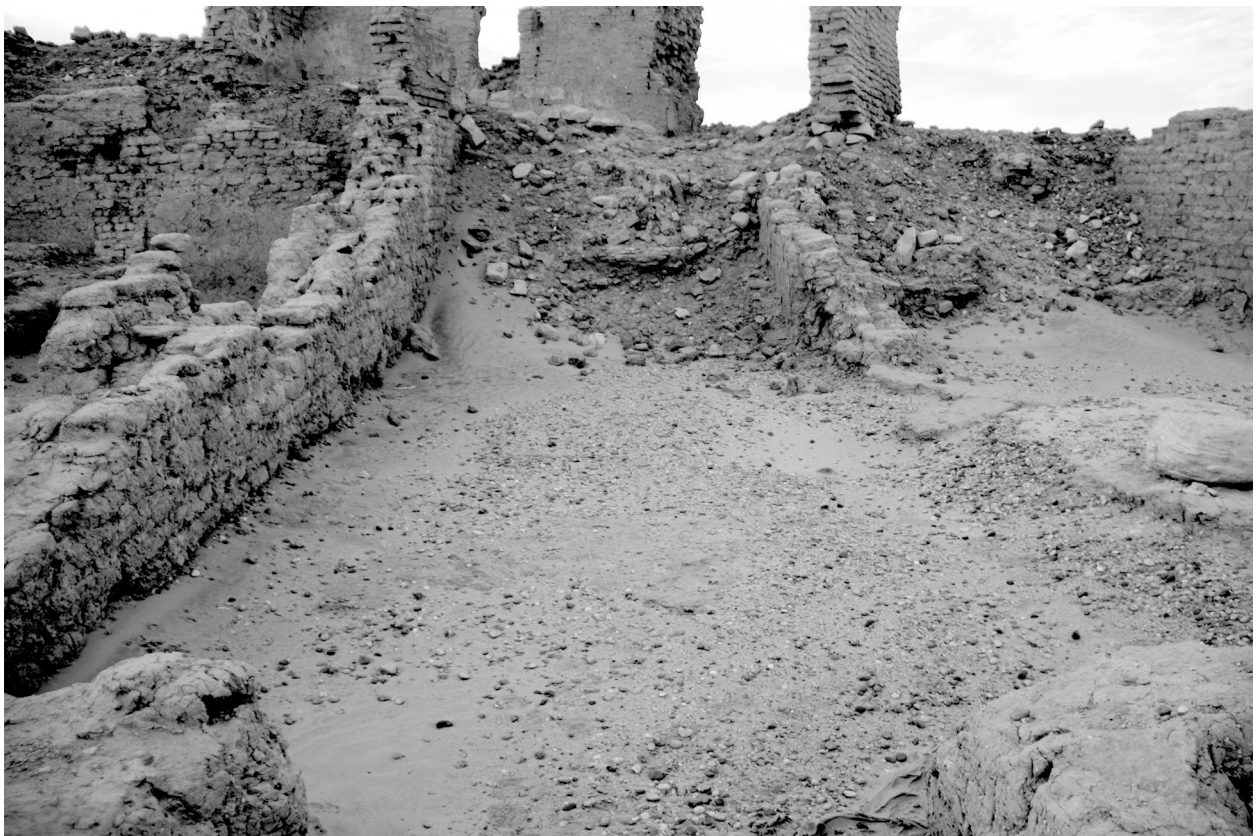
Pl. 25.2. Storage room M5, view from the north

The storage rooms M5¹³⁶ (Pl. 25.2) and M6¹³⁷ (Pl. 26.1) are not preserved in their entirety, since the southern parts of these two rooms are covered in rubble from the Ottoman fortress. Additionally, of the north-south oriented wall between these two magazines, only about 3.72m on the southern side still exists, while the northern part has deteriorated. Nevertheless, the former sizes of the rooms can be reconstructed by extending the dividing wall to the north and south, and presuming that the southern wall was aligned with the southern walls of the previous magazines. The reconstructed floor surfaces result in 46.71m² (M5) and 50.23m² (M6), making them similar in size to the other storage rooms in this sector. Of the 1.36m wide door in M5, part of the original threshold still exists on the western side of the opening, situated on one course of bricks. The small wall to the east of the doorway, as attested in the other storage rooms, could not be detected here, though presumably it existed. From the 1.30m wide door in M6, only one course of bricks remains, on which a stone threshold probably lay. Here, once again, a small wall was added onto the wall to the east of the entrance, jutting out into the room for 0.41m. The remains of two overlapping silos exist at the floor level, later overbuilt by the dividing wall of the two storage rooms.

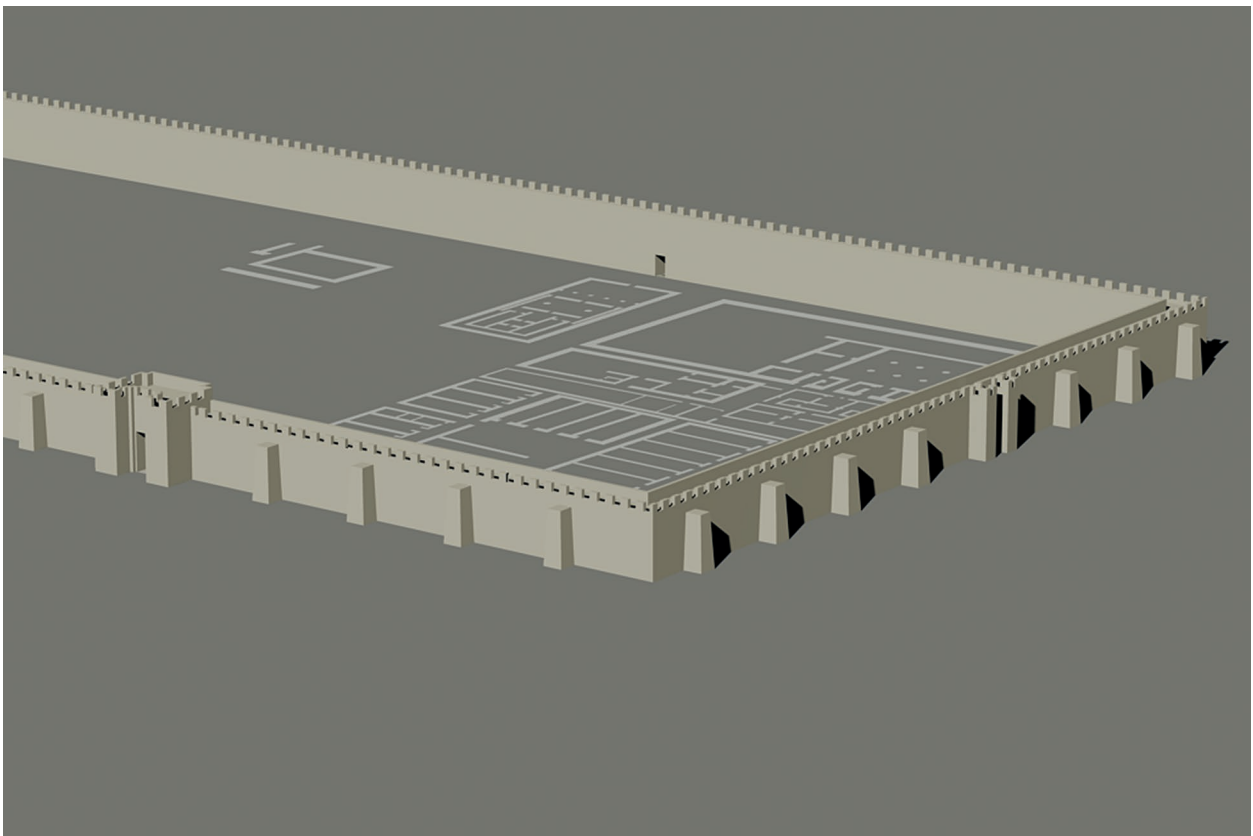
Pl. 55.2. 3-D reconstruction of the southern part of the fortifications, view from the southwest

As for the 3-D reconstruction of the fortifications (Pl. 55), it must be noted that the *in situ* remains were not very high and therefore the height

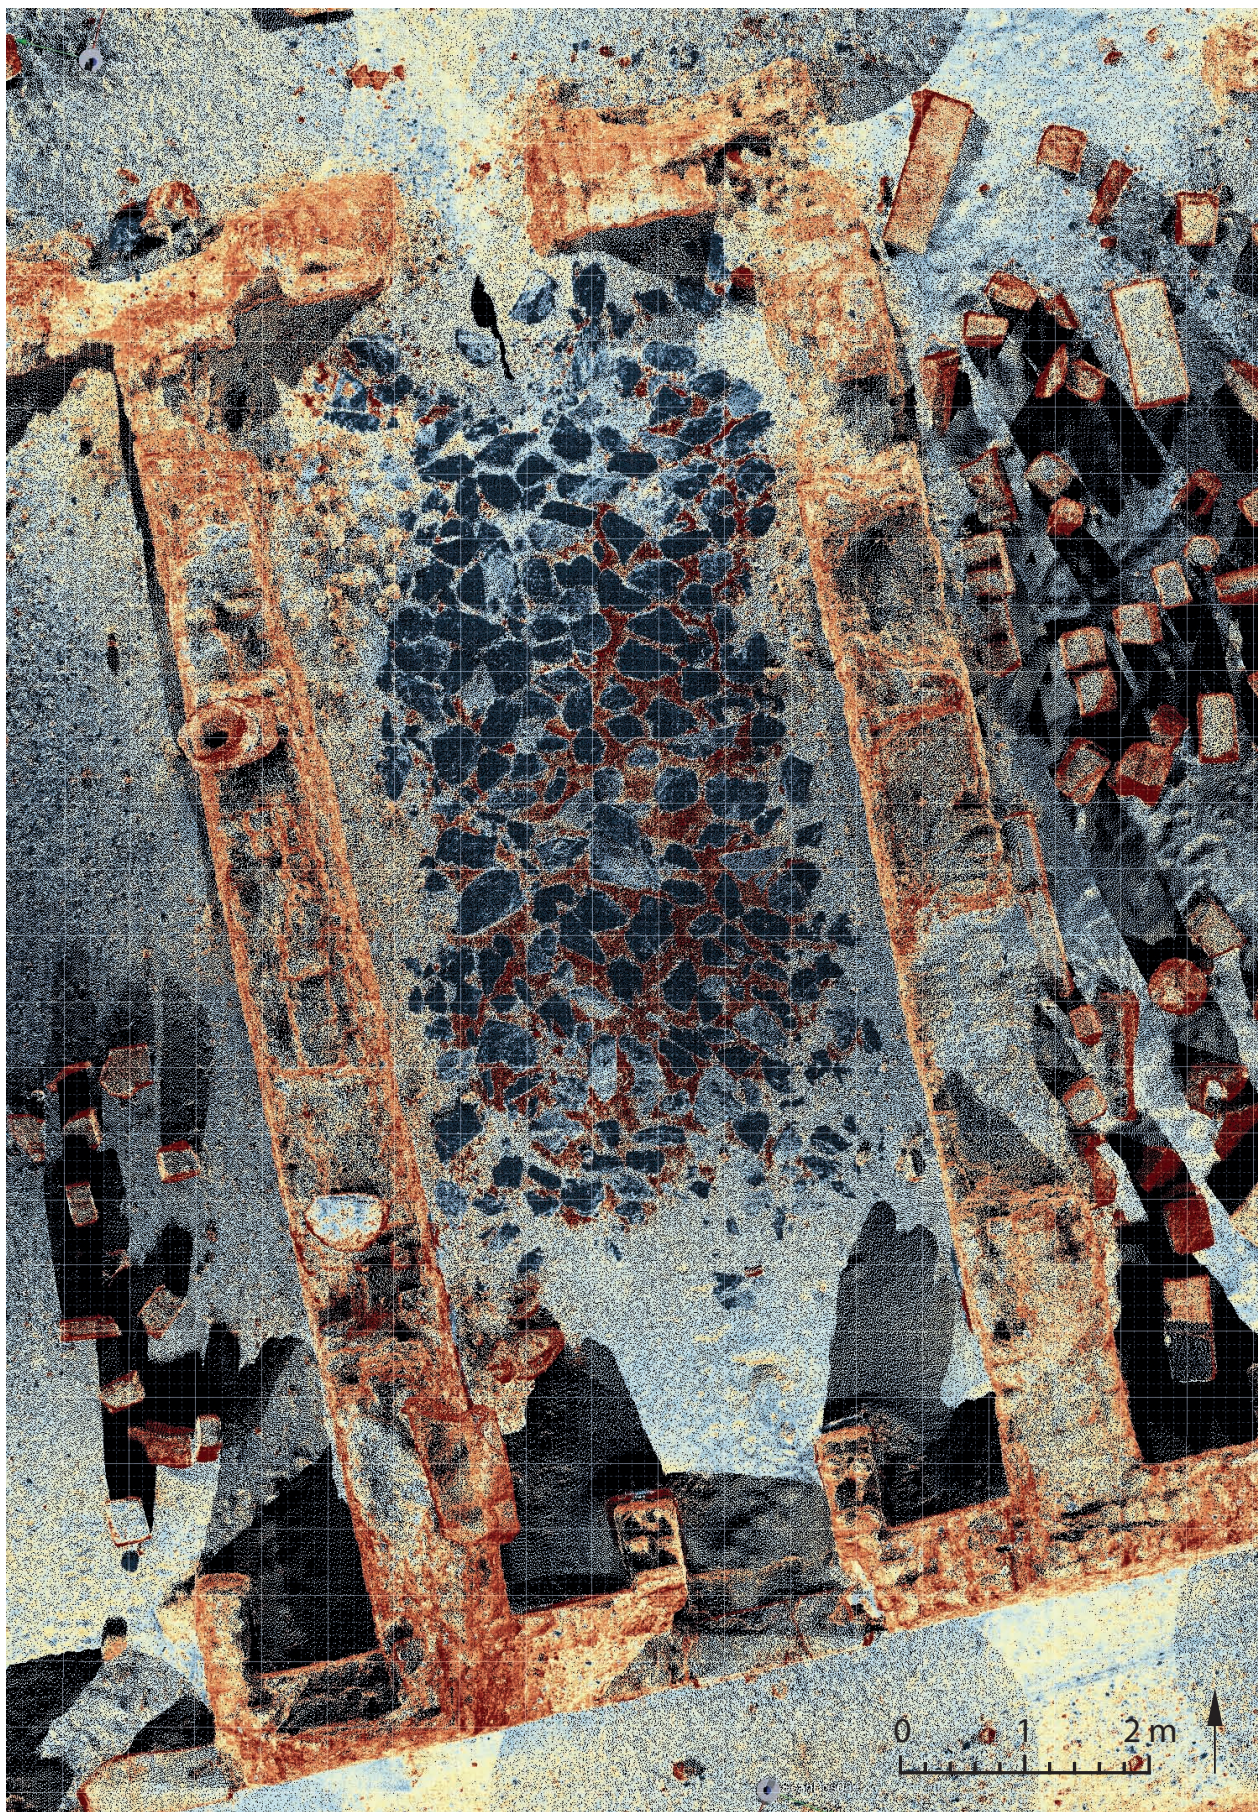
Pl. 56. Schist floor of storage room M14, extract from the 3-D laser scan

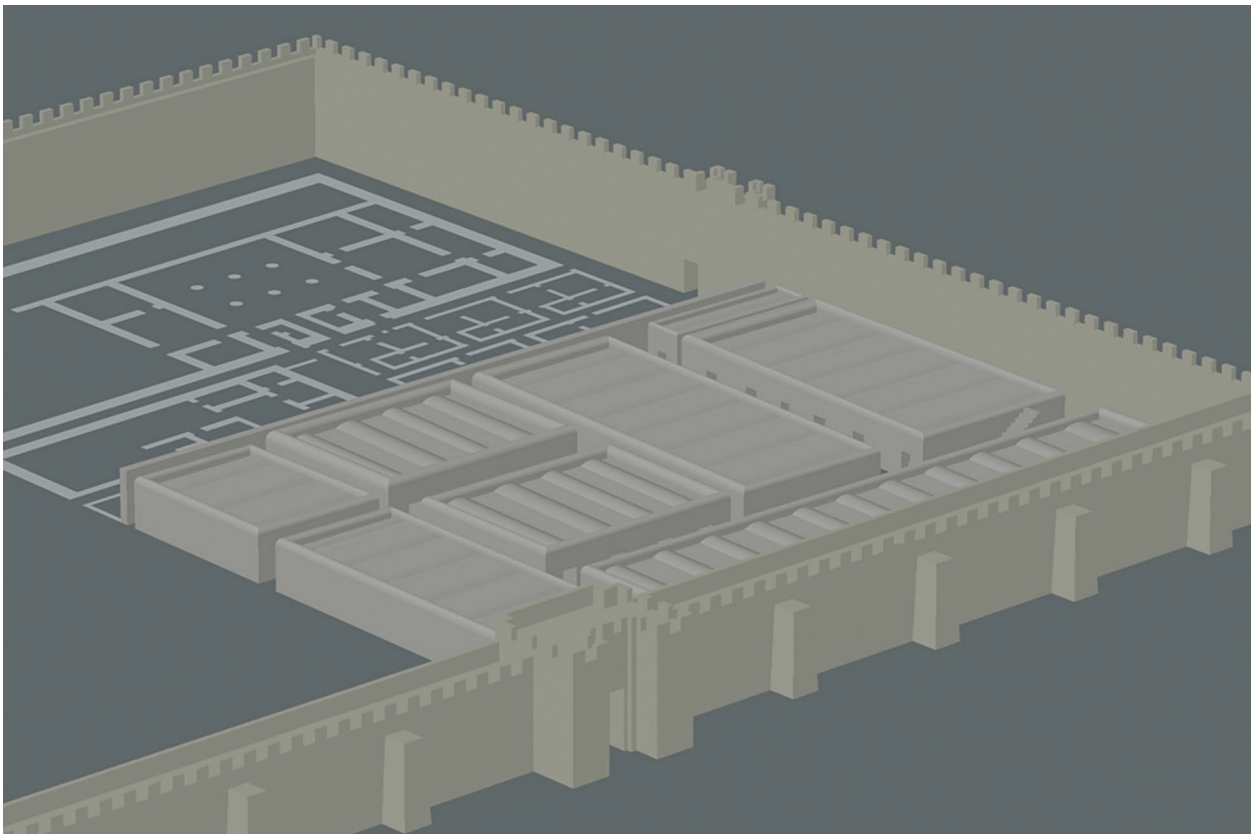
Pl. 57.2. 3-D reconstruction of the storage area SAF5 with a suggested row of magazines in the western part

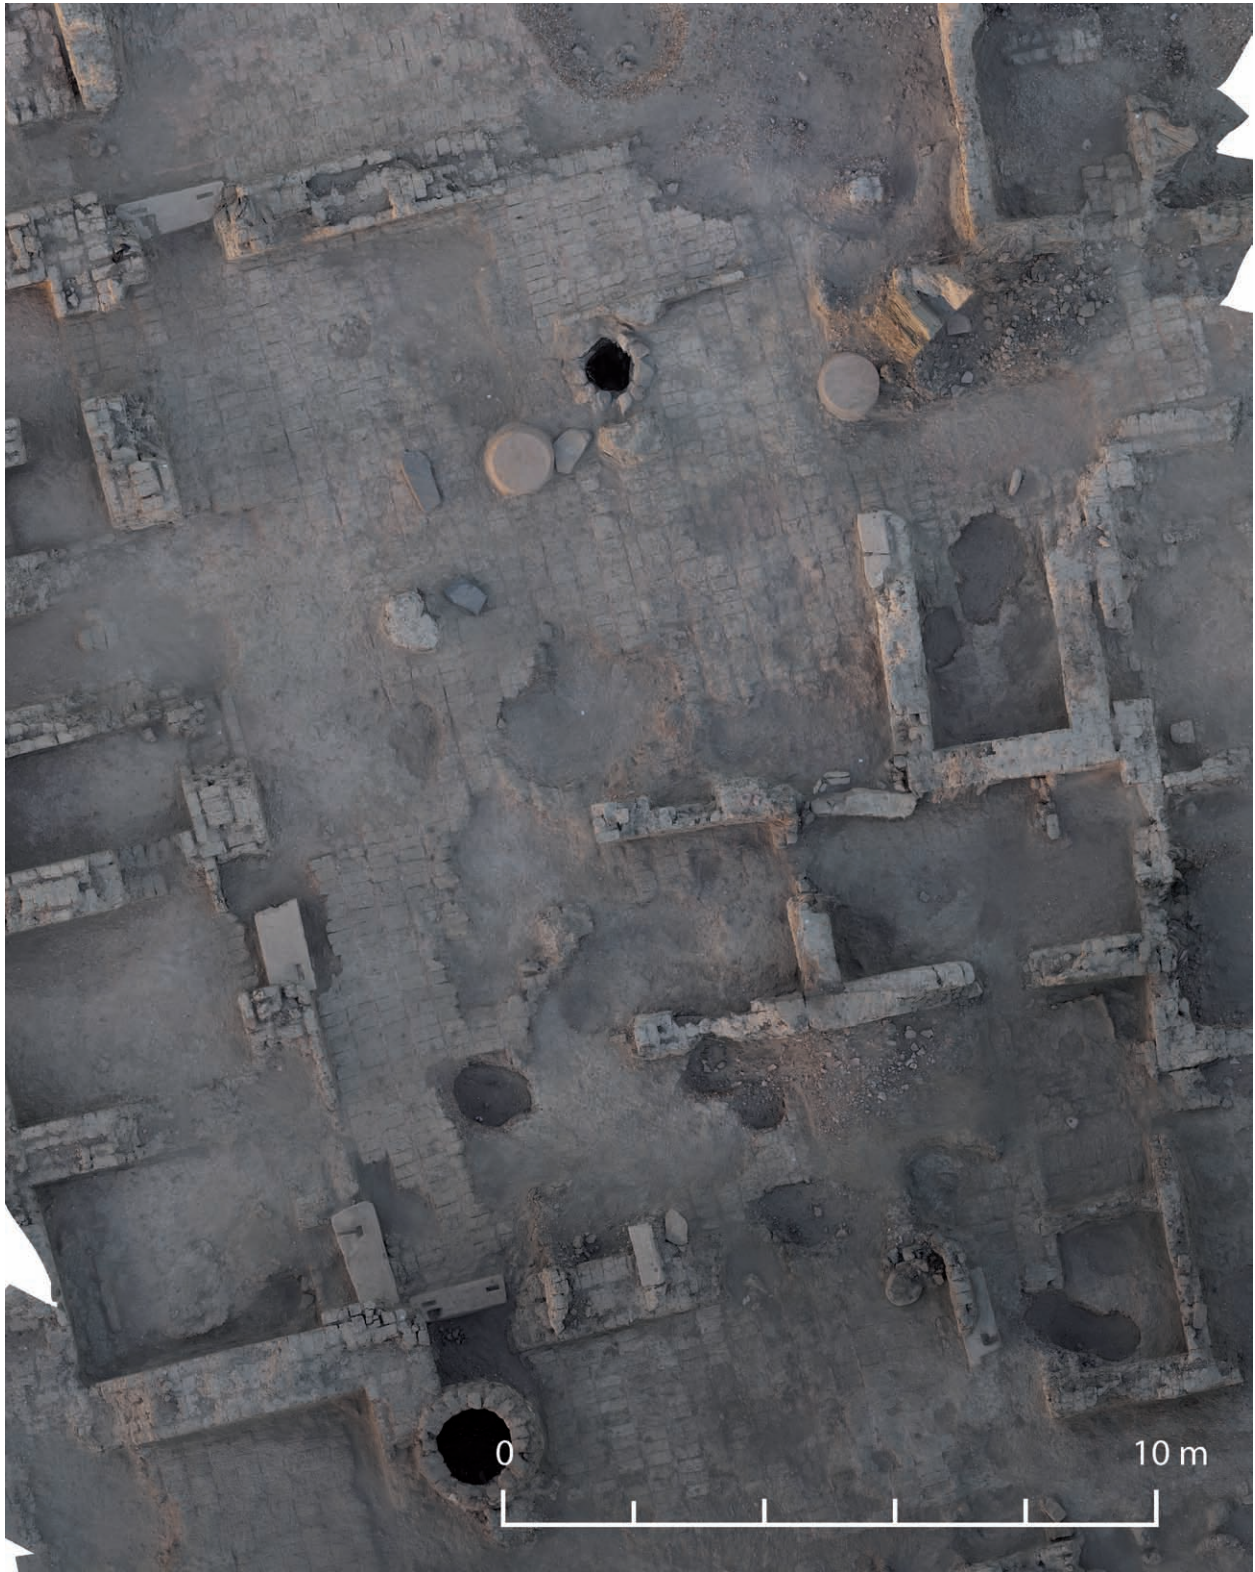
Pl. 59. Orthophoto of Room SAF2/9, showing the mudbrick pavement

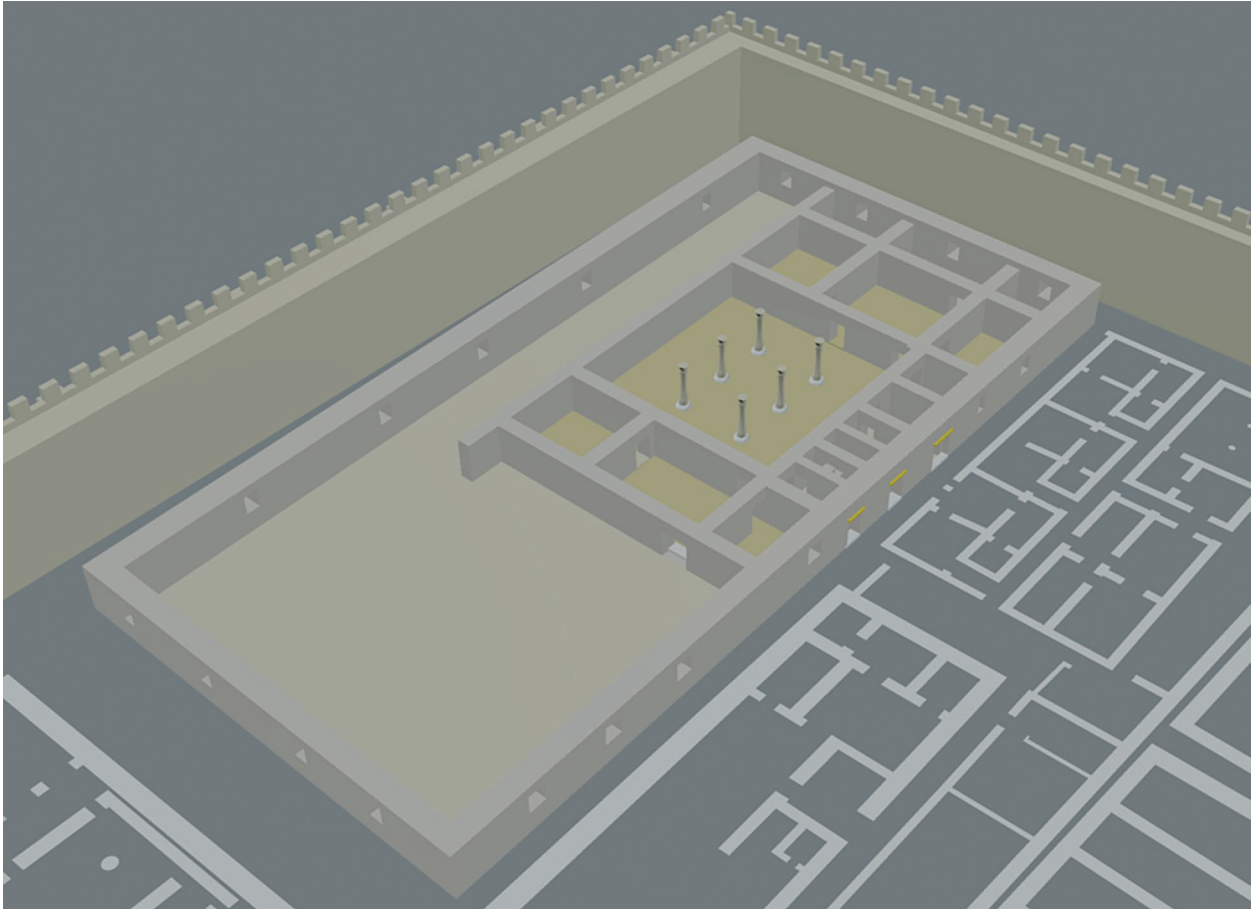
Pl. 61.1. 3-D reconstruction of the ground floor of SAF2, view from the northwest
