Excavations at Portchester Castle

Volume III: Medieval, the Outer Bailey and its Defences

Barry Cunliffe, M.A., Ph.D., F.S.A.

1977

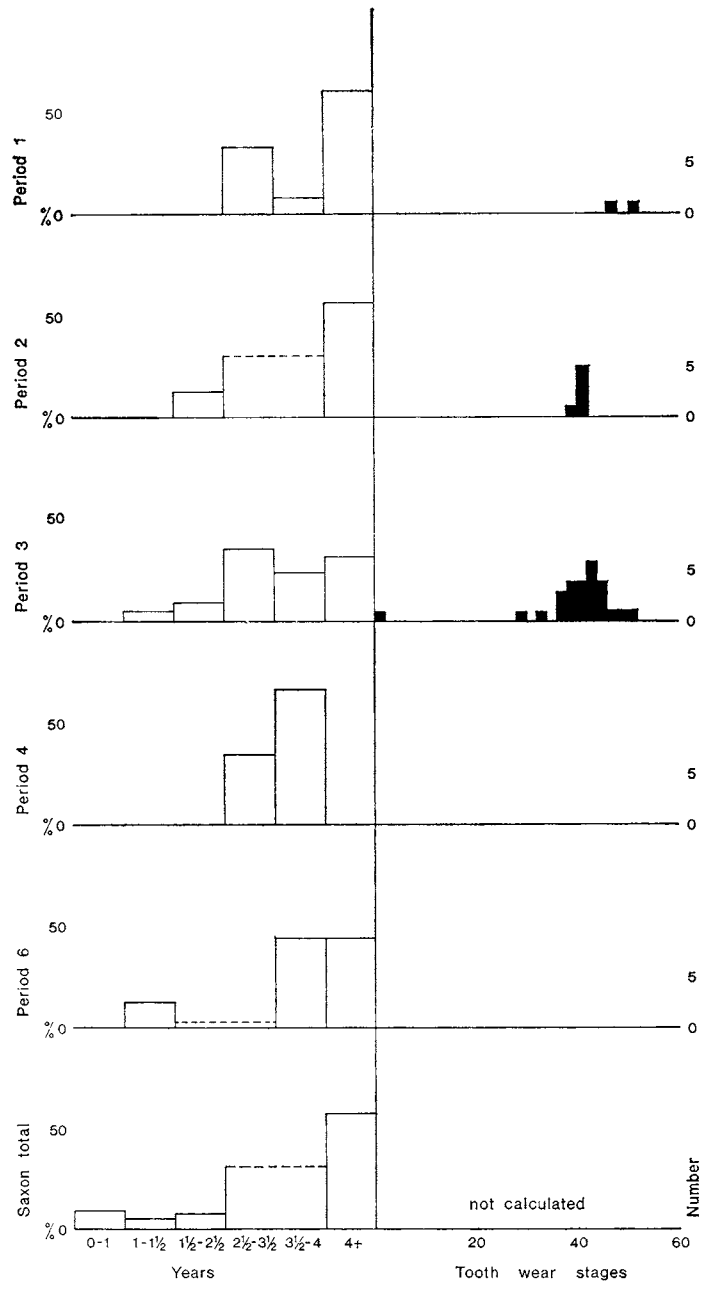
FIG. 116. Age structure of cattle bones

The analyses of the cattle bones are seen in Table Va and fig. 116. The group 3 results (the only group with an adequate sample) show that the majority of the animals had been killed between 2½ and 3½ years, and that only 31% of the bones were from animals of more than four years. In both Saxon and Roman periods between 50 and 70% of the animals were over

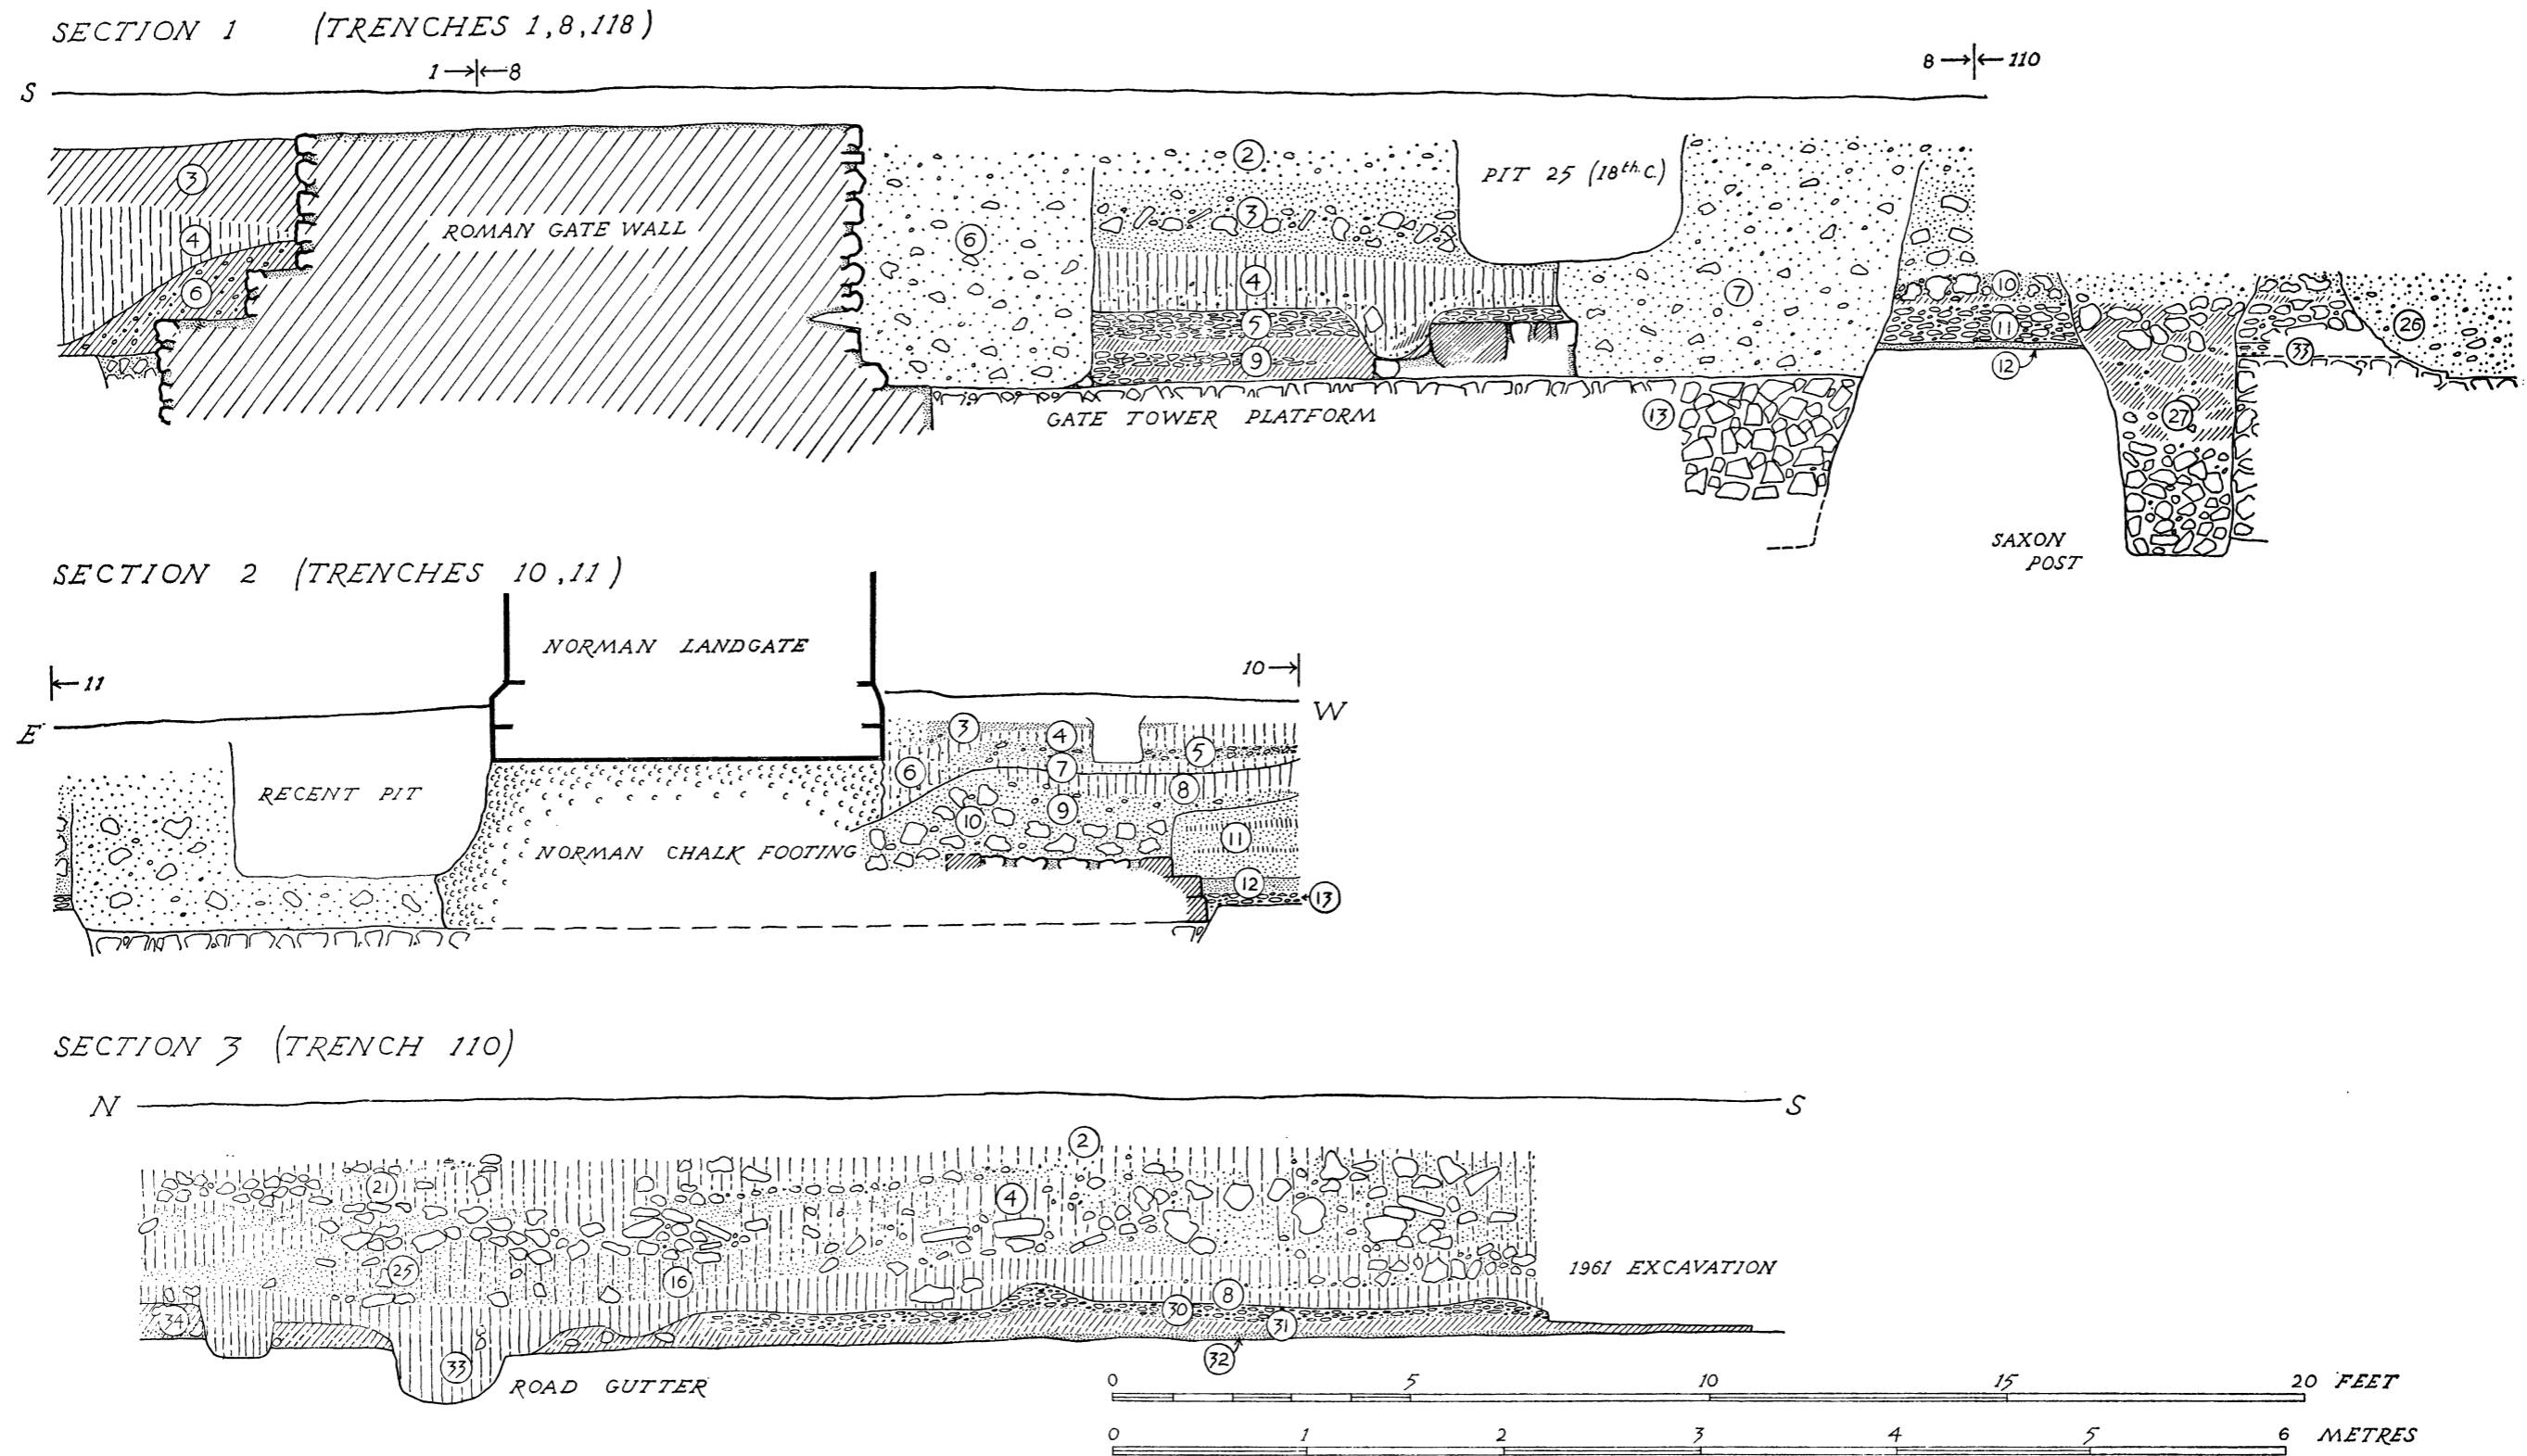
FIG. 122. Sections of the landgate

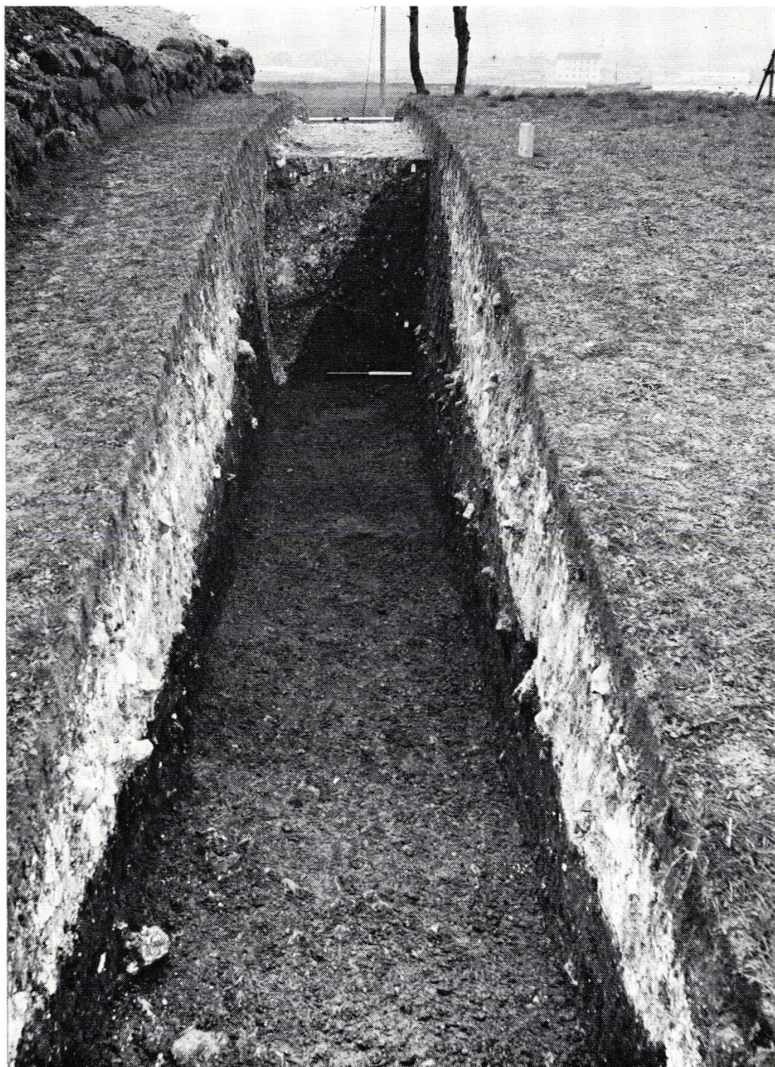
a. The outer earthwork: section 1 showing rammed chalk foundation in the cross section
(photo: David Baker)

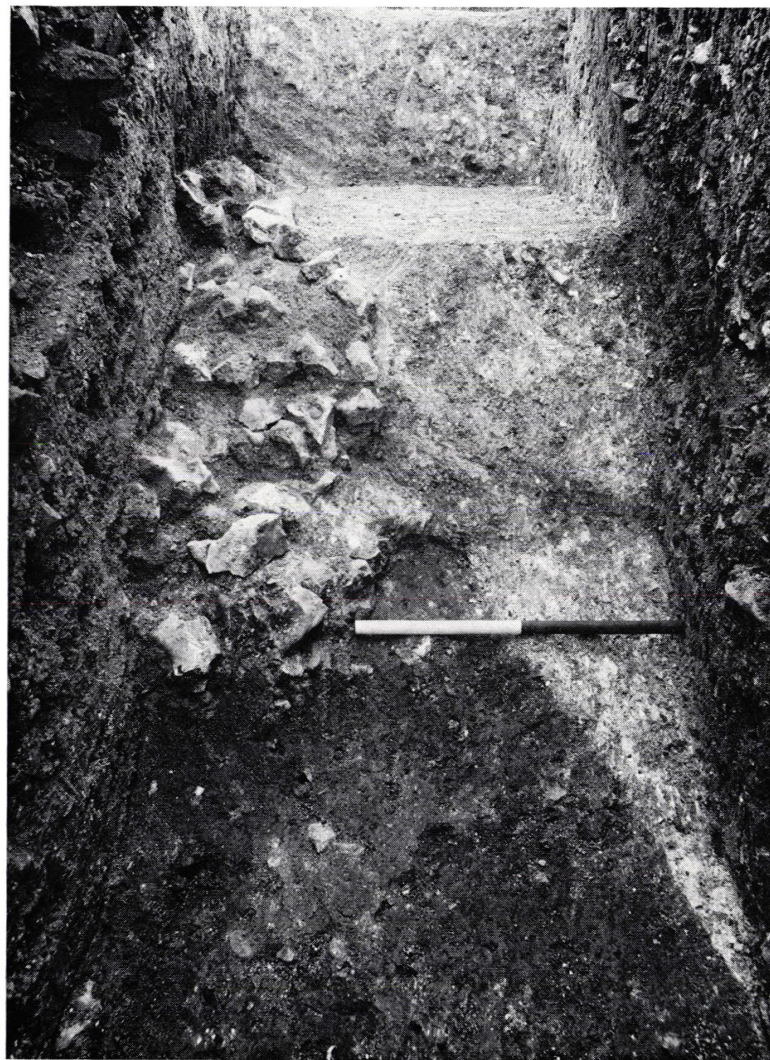
b. The outer earthwork: section 1, front face, showing the flint and mortar rubble cut by the rammed chalk foundation
(photo: David Baker)

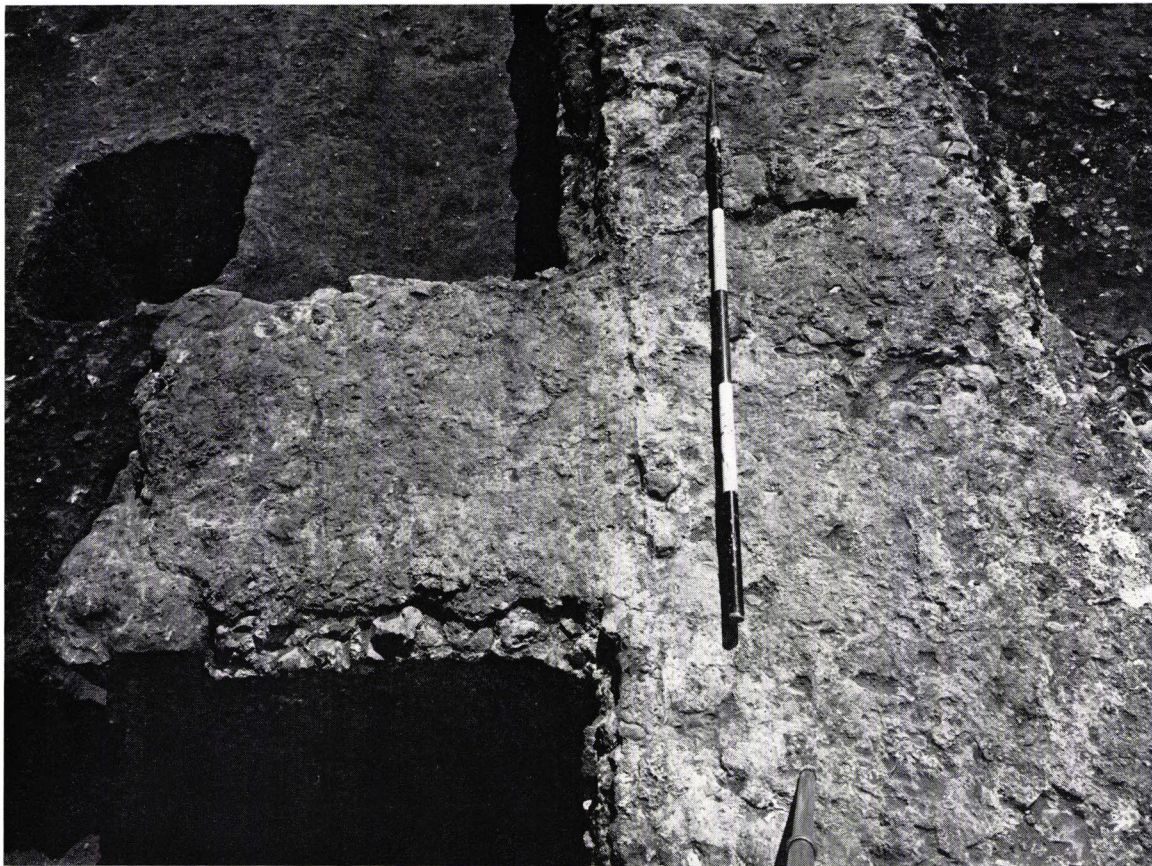
b. Storehouse foundation showing bedding mortar for the superstructure ignoring the foundation buttress
(photo: David Leigh)

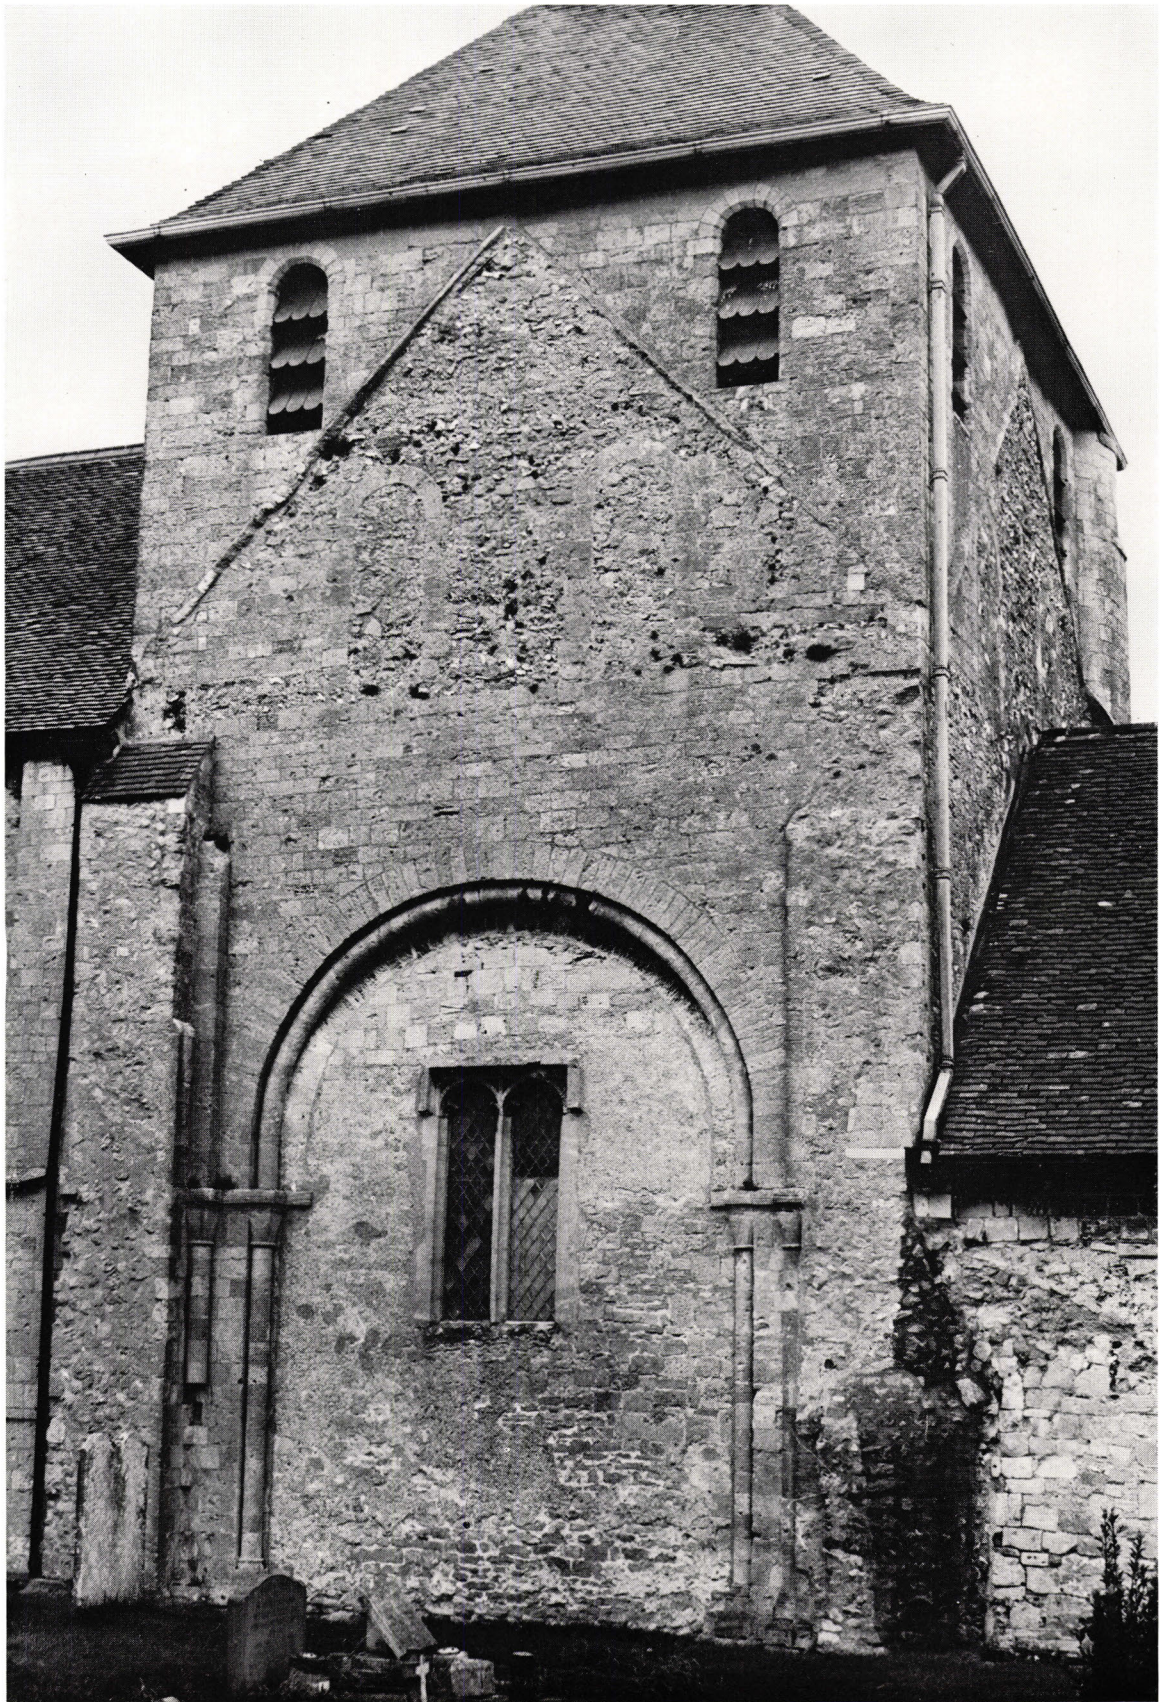
St. Mary's Church: face of south wall showing the abutment of the demolished south transept
(photo: David Baker)

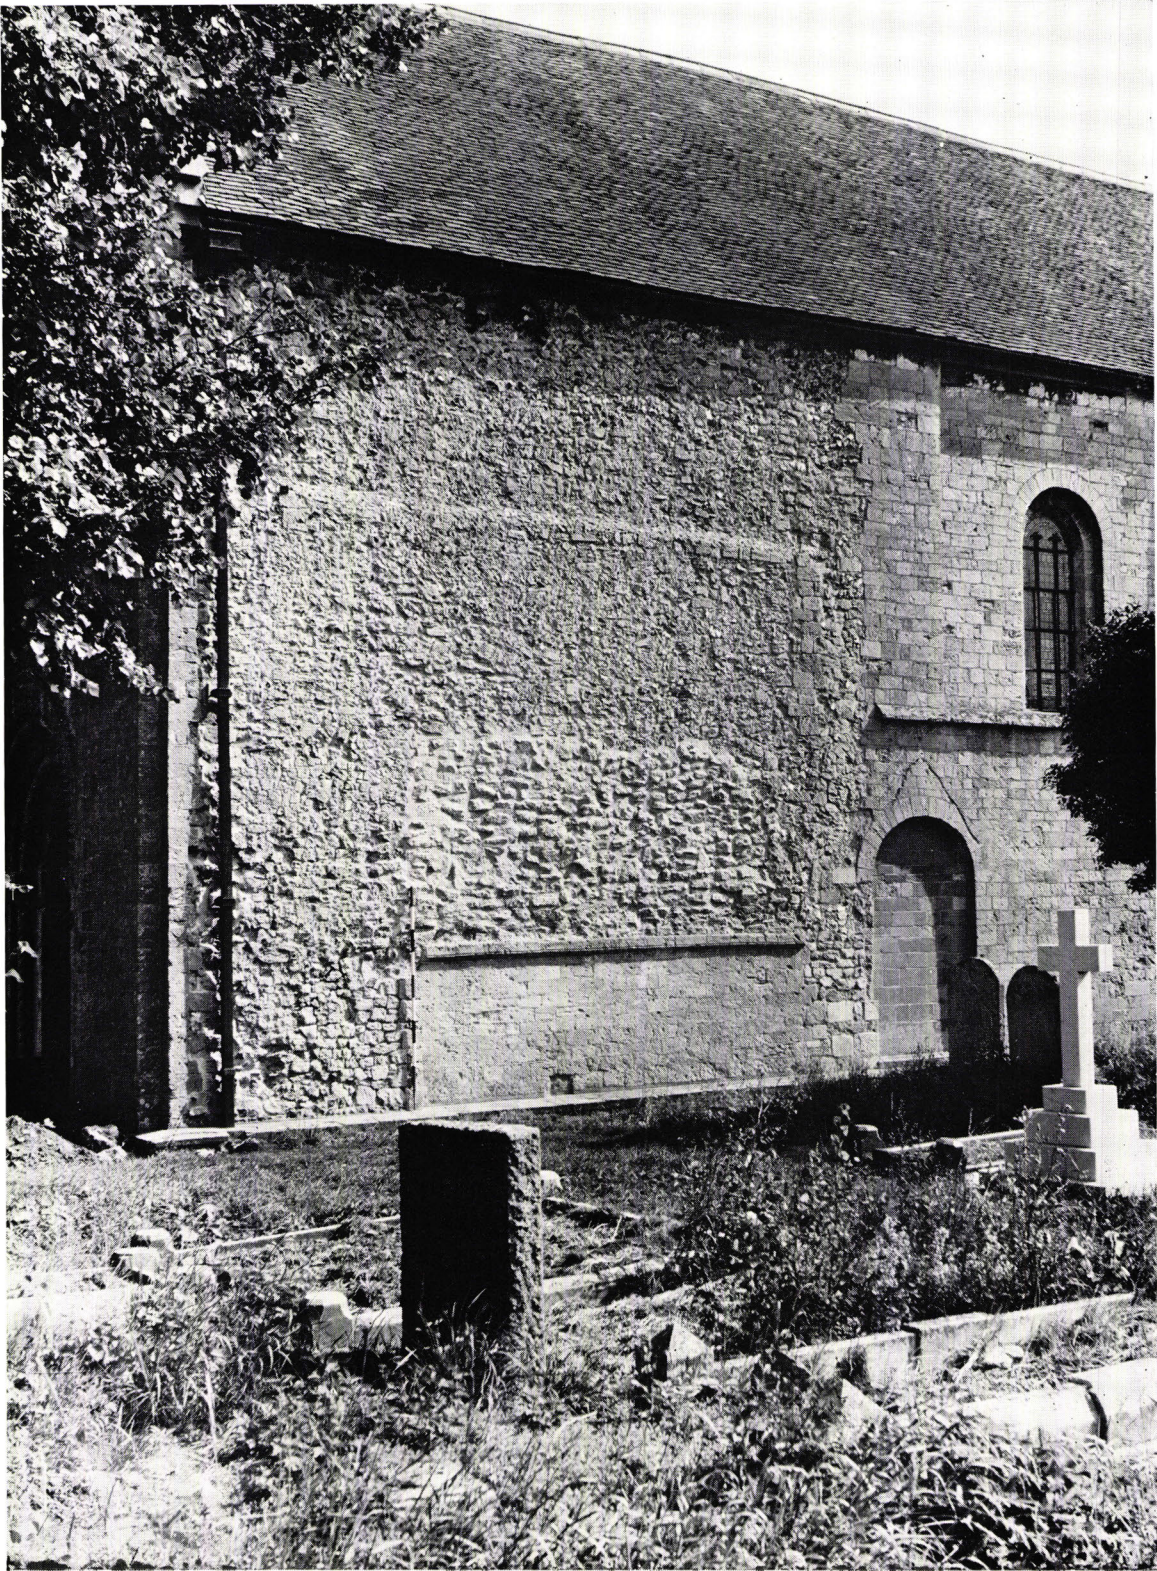
St. Mary's Church: face of south wall showing the abutment of the demolished west range
(photo: David Baker)
